Inspection Report

Property Address:
1856 Alpine Way
Duluth GA

Dana Home Inspections, Inc.

Date: 8/22/2016**Property:**1856 Alpine Way
Duluth GA**Customer:**

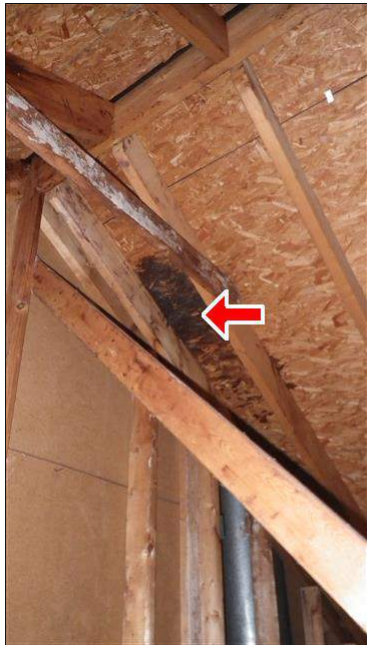
- 1. Several active leaks detected inside the attic, including some decking damage.
- 2. Deteriorated plumbing vent boots.
- 3. Unusual rafter separation that is allowing a lot of daylight (and possible moisture) into the attic.
- 4. One cracked rafter.
- 5. Cracked overhanging ridge shingles.
- 6. Leaking around the skylight, as detected using an infrared camera and moisture meter.

Leak

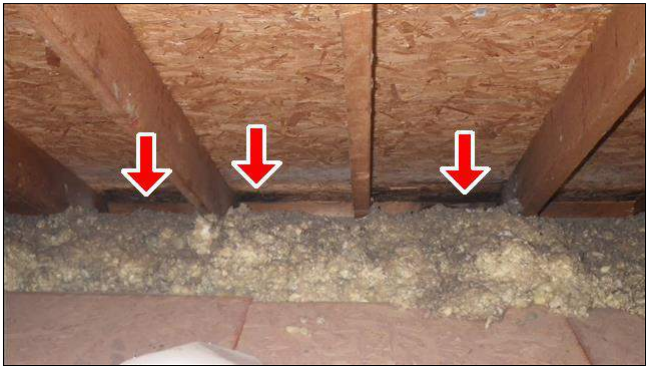
Leaks

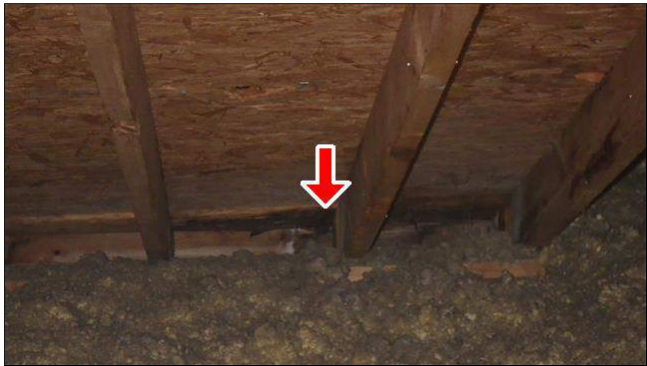
Leak

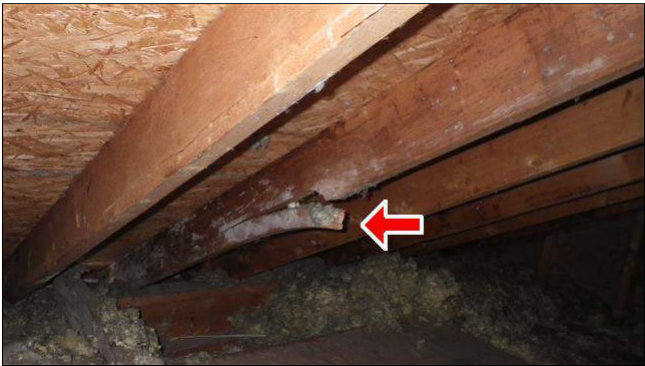
Cracked rafter

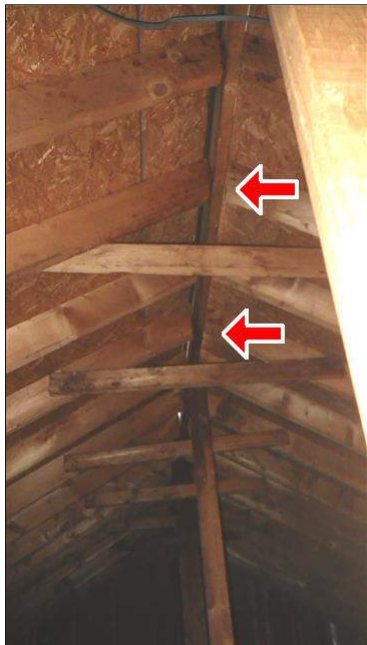
Separation at rafters

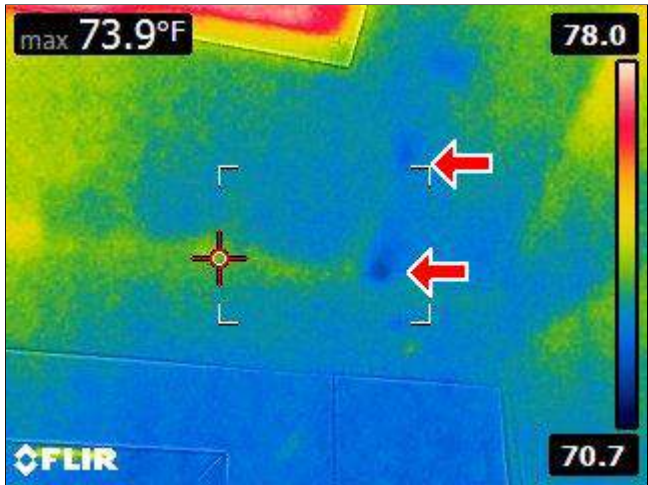
Infrared of leaking at skylight

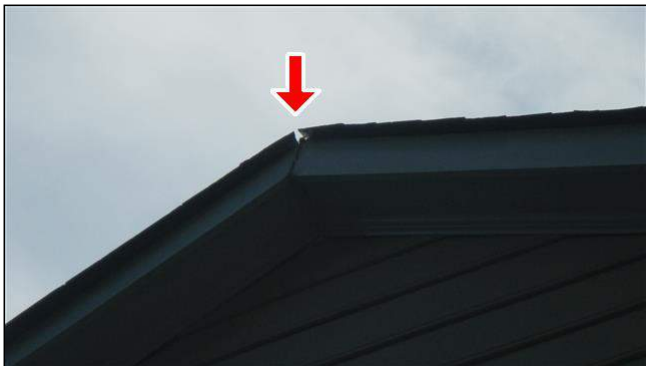
Cracked ridge shingles

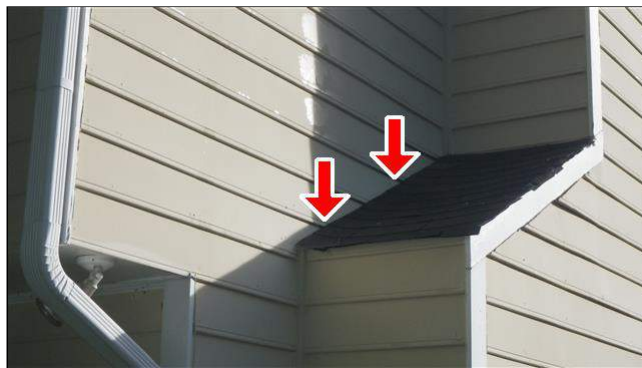
Sidewall flashing at the small roofed areas of the chimney chase do not appear to be installed well and should be further evaluated and repaired by a qualified roofer.

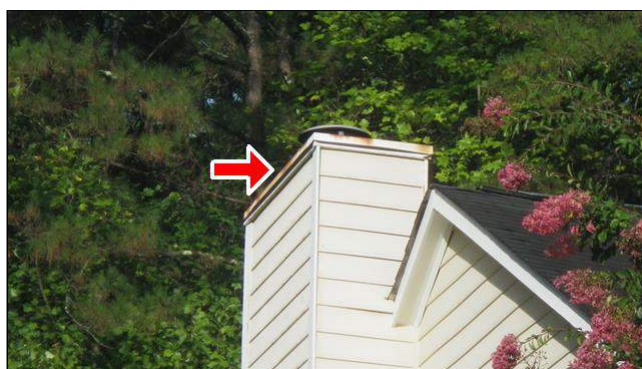
(1) Rust was observed on the chimney cap. This should be cleaned and painted with a rust inhibitor to prolong its useful life.

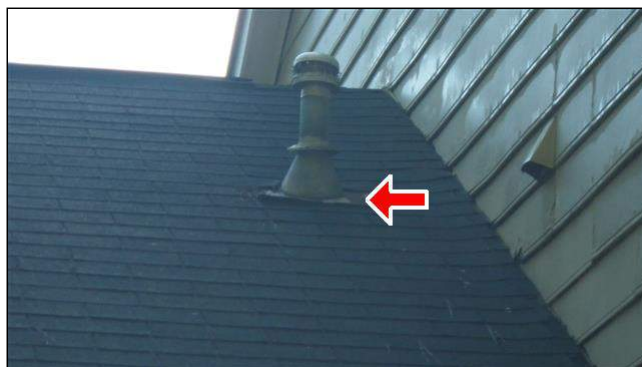
(2) Rusting metal vents above the roof should be painted with a rust inhibitor to prolong their useful lives.

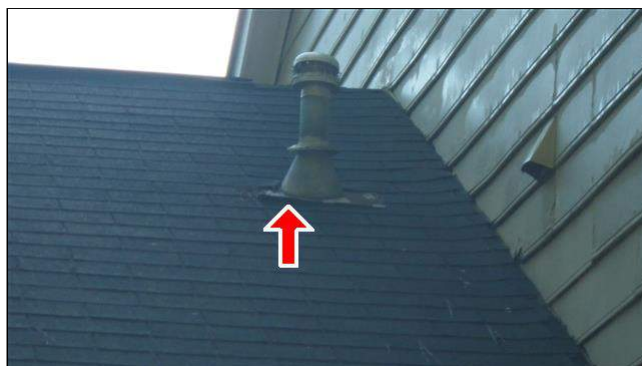
(3) The water heater exhaust vent nailing flange is bent upward, which increases the potential for moisture penetration.

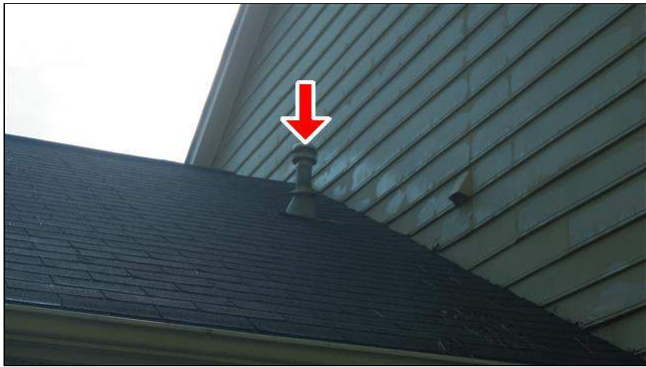
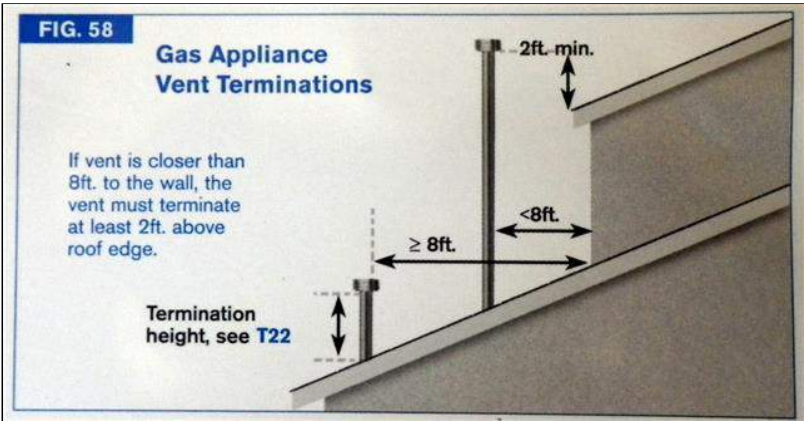
(4) The water heater exhaust vent at the back of the house should be repaired to terminate at least 8' from the adjacent sidewall.

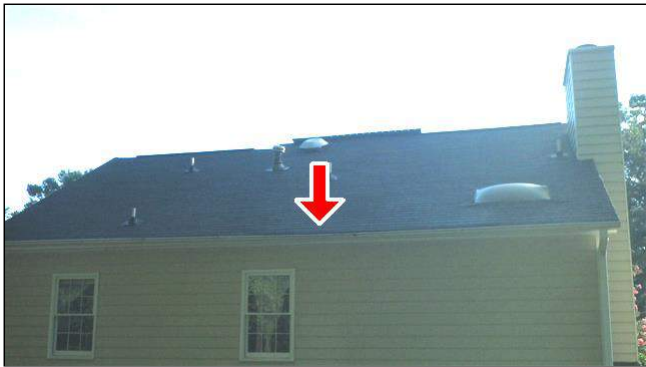
Comments: Repair or Replace
The back gutter appears to be sagging in one area.

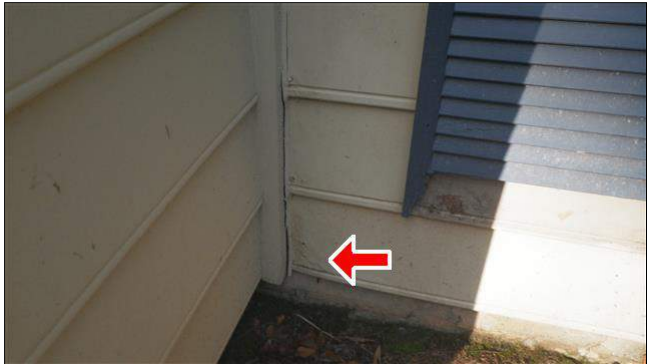
Front

(1) The fiberboard siding is in generally good condition, with some areas having been replaced with more durable fiber-cement siding. However, there were several areas of the remaining fiber board siding around the house that are deteriorated and in need of repair or replacement. It is recommended to have the siding further evaluated and repaired or replaced as needed by a qualified contractor.

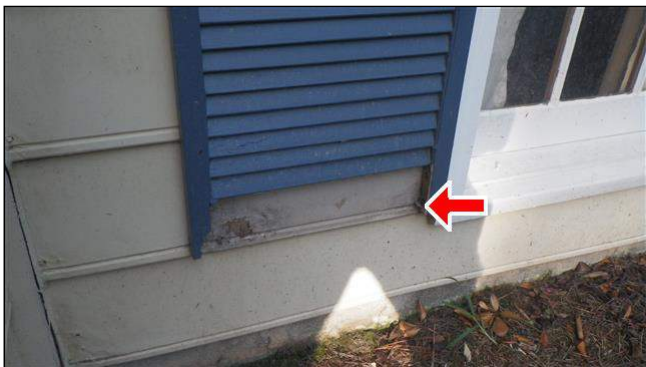
(2) Some of the window shutters are in poor condition.

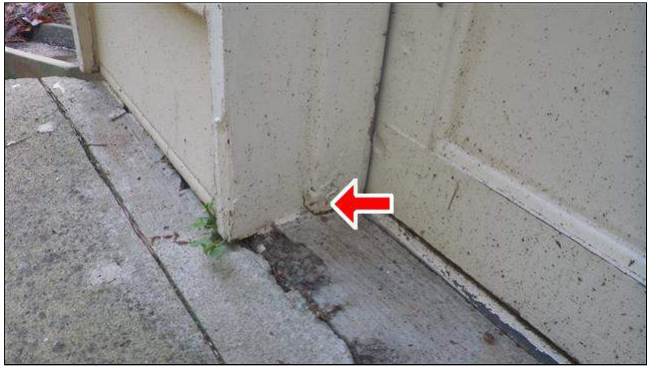
Garage

(3) A few areas of soft or deteriorated wood trim was observed around the house.

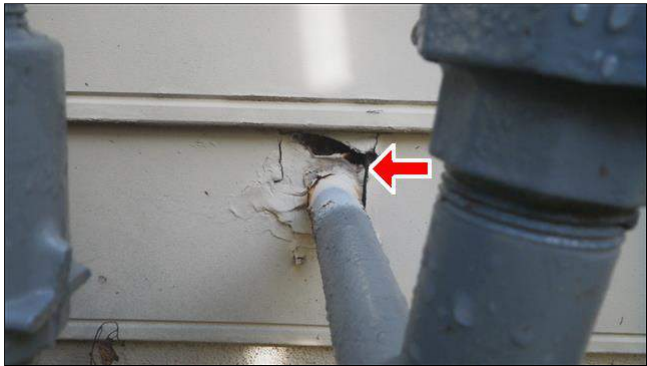
Gas meter pipe

(4) All exterior penetrations in the siding (e.g., lights, vents, etc) should be properly sealed with exterior silicone to prevent moisture intrusion.

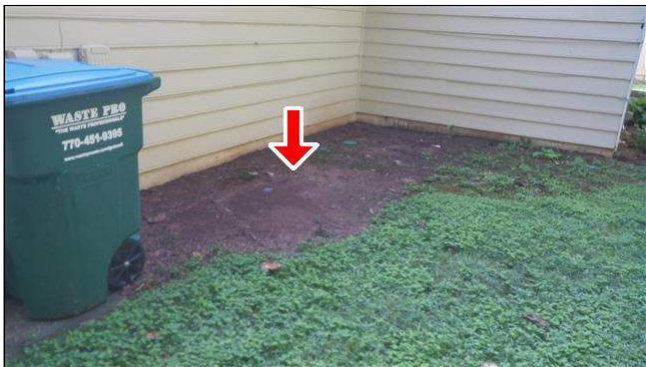
(1) One area of the yard directly behind the garage does not appear to be draining water well.

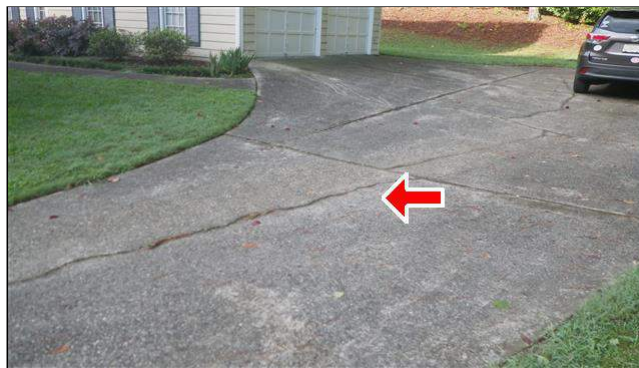
(2) Common settling cracks were observed on the driveway.

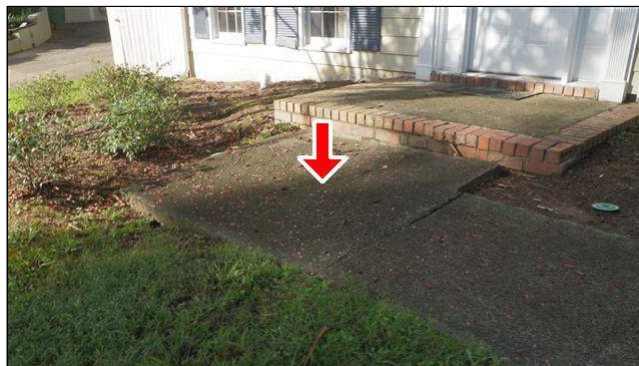
(3) Common settling movement was observed at one section of the front concrete walkway.

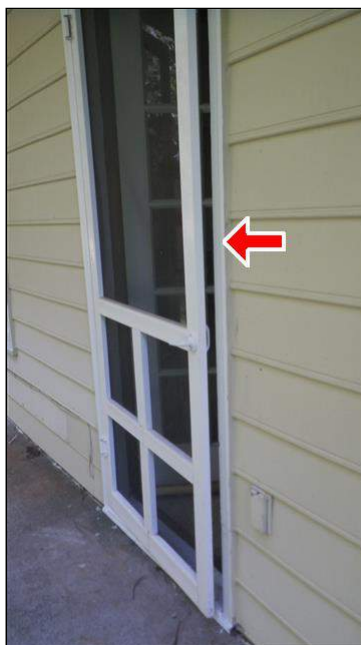
The back screened door does not latch shut.

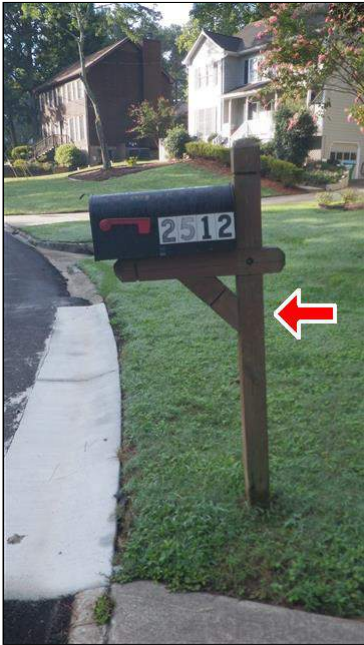
- 2.5 WATER METER
- Comments: Inspected
- 2.6 WINDOWS
- Comments: Inspected
- 2.7 VENTS/VENT HOODS
- Comments: Inspected
- 2.8 OTHER
- Comments: Repair or Replace
- The mailbox is a little loose.

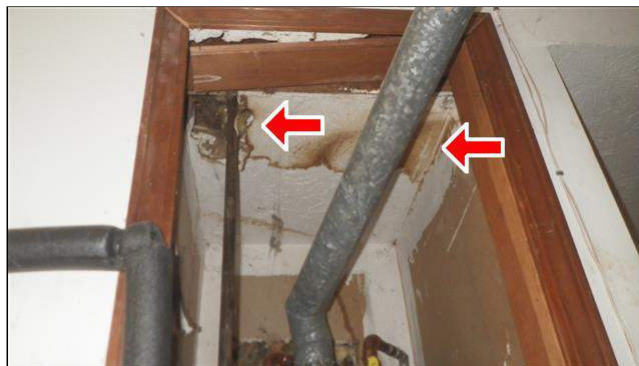
- 3.0 GARAGE CEILINGS
- Comments: Monitor
- A moisture stain was observed on the garage ceiling above the water heater but tested as dry using a moisture meter and appears to be an old stain. Recommend cosmetic repairs and monitor for changes.

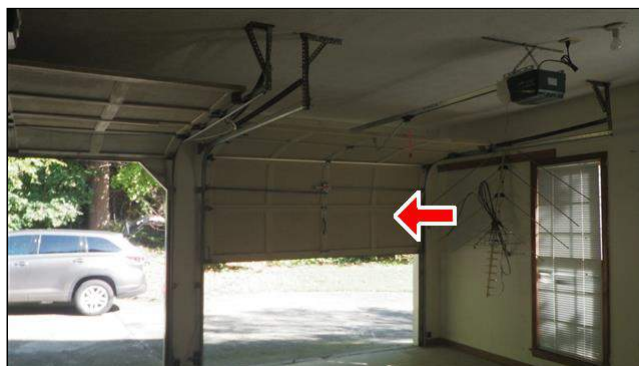
One of the two overhead garage doors does not fully open.

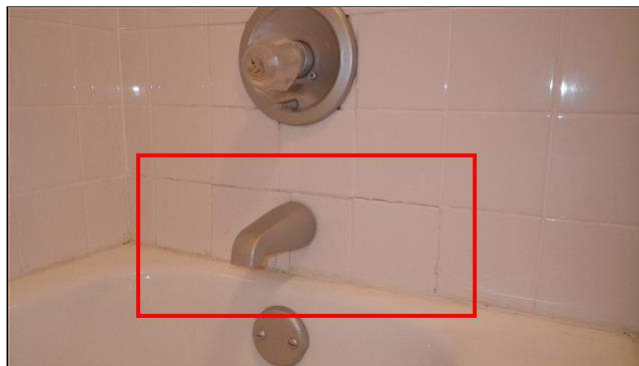
The tiles around the guest bathtub spout are coming loose.

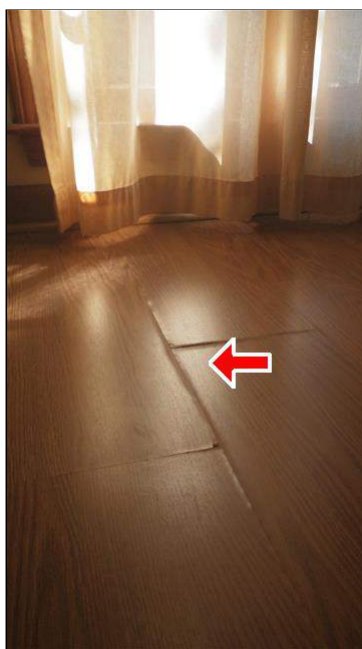
Active wetness was detected at a swelled area of the flooring inside the front living room. The area was tested with a moisture meter and showed high levels. The flooring should be removed and the issue further evaluated and repaired as needed.

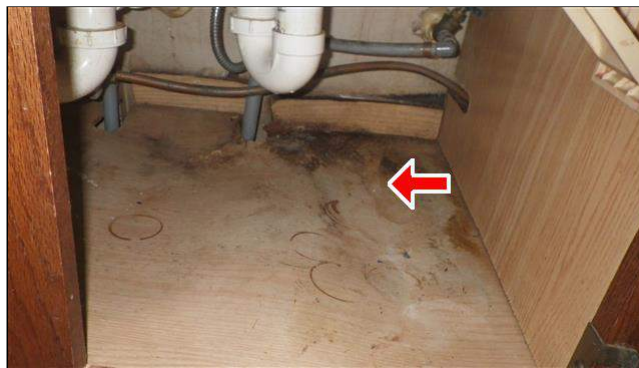
(1) The bottom of the kitchen sink cabinet is in very poor condition from previous exposure to moisture. No active leaking was observed, but replacement is needed.

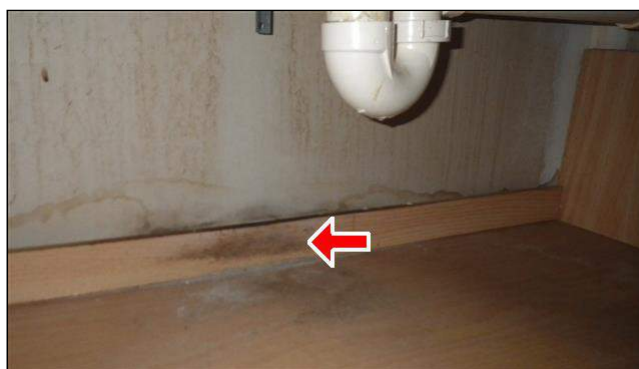
(3) Mold-like substances were observed inside some of the sink cabinets. Although common, if mold is a concern for you the living space should be further tested for by a qualified mold testing professional and removed as needed.

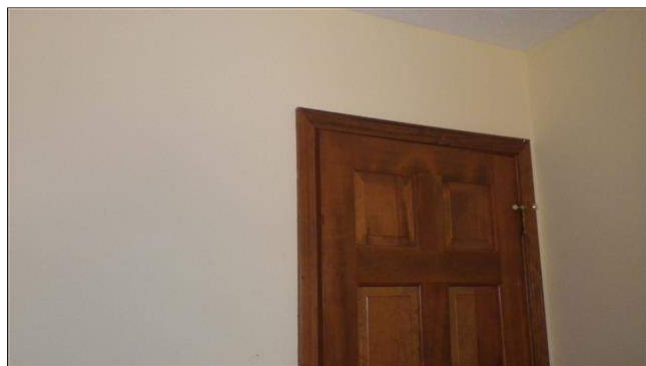
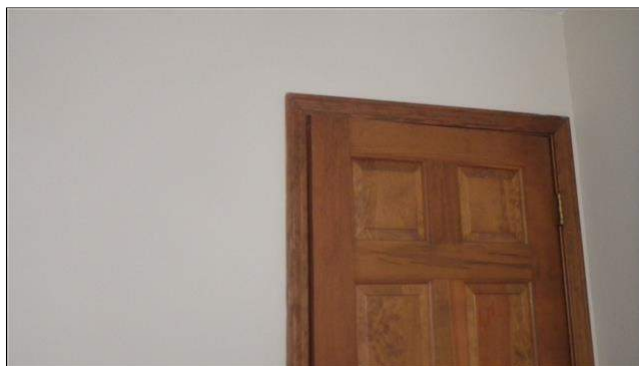
(1) Due to apparent settling of the door frames, two of the 2nd floor bedrooms doors rub against the door frame when used.

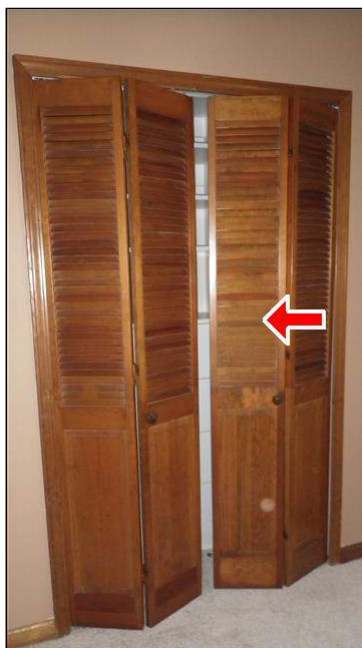
(2) A 2nd floor guest bedroom folding doors is not shutting properly.

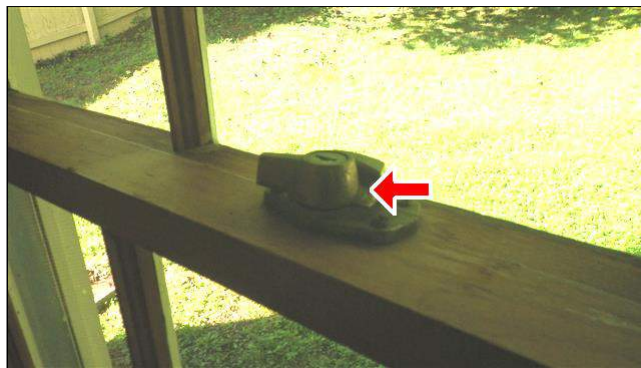
(1) Contact the owner to understand if there is a key available for all of the window locks.

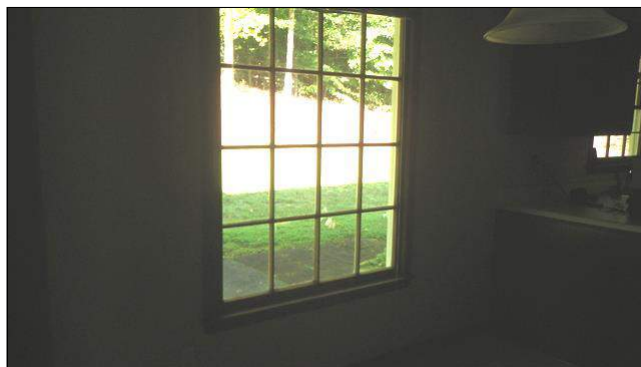
(2) The original windows are still installed in the house. It is recommended the windows be replaced with more energy efficient double paned ones.

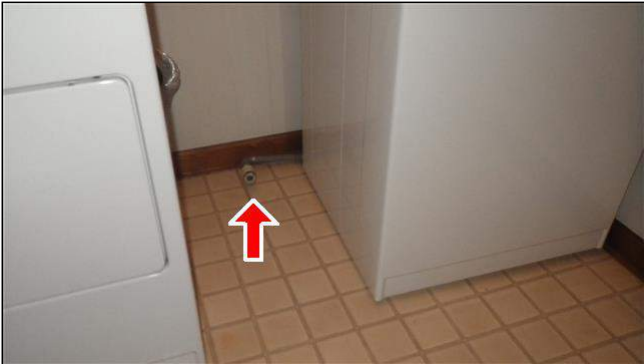
A drip pan is needed for the available laundry floor drain and the dishwasher should be placed in the pan to catch any future leaking.

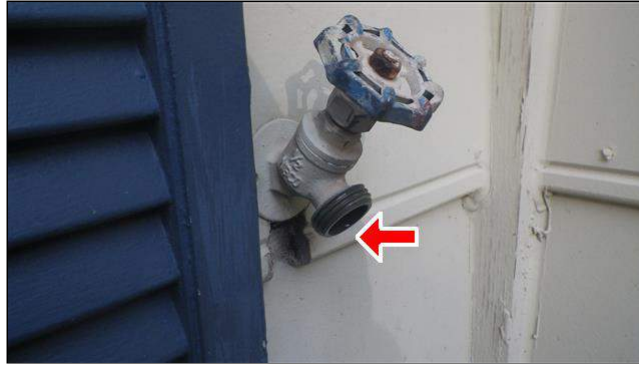
(1) The front hose bibb continually drips.

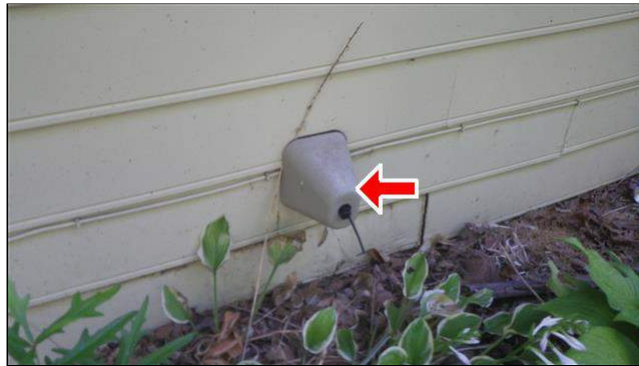
(2) The exterior back hose bibb has been winterized and could not be tested. Have operation verified by the seller or qualified individual.

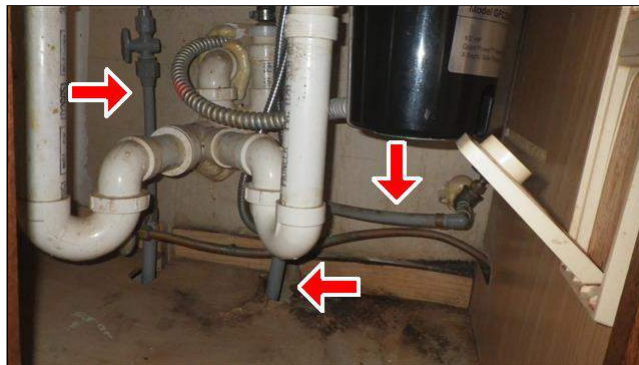
(3) Polybutylene plastic plumbing supply lines are installed in the house, which has a higher than normal failure rate that was subject to a class action lawsuit in years past. Copper and Brass fittings have apparently reduced the failure rate but failure is still possible. The house should be further evaluated by a qualified plumber and all Polybutylene piping replaced. The main line from the street does appear to have already been replaced.

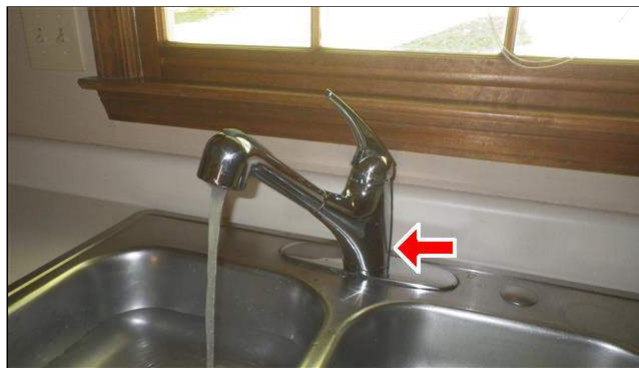
(4) The kitchen sink faucet is not adequately secured to prevent movement.

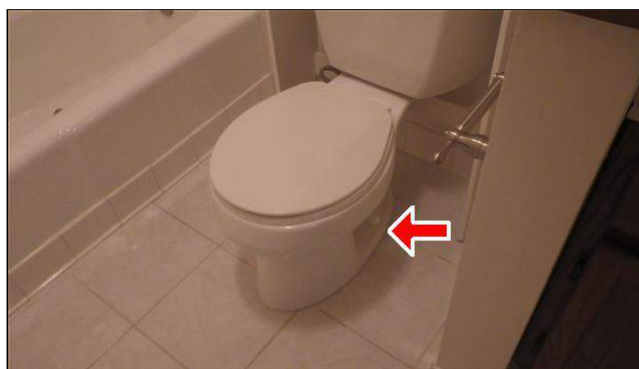
(6) The guest toilet is very loose from the floor and may indicate a broken flange or problems with the bolts or subfloor. It may also cause leaking. The unit should be removed, the subfloor checked for damage and repaired as needed, and the toilet reinstalled by a qualified plumber.

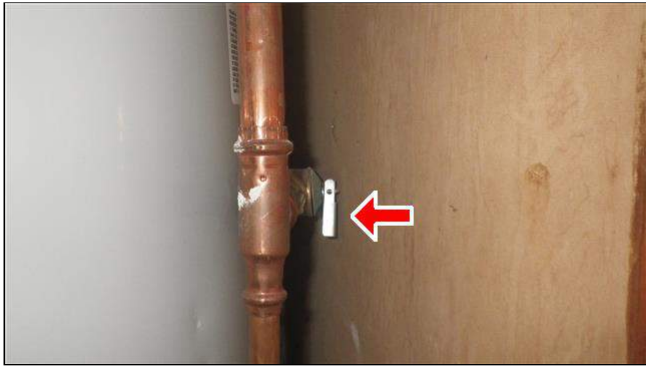
The hot water heater was installed in a manner that made the T&P valve unable to be tested as it is pressed up against the wall.

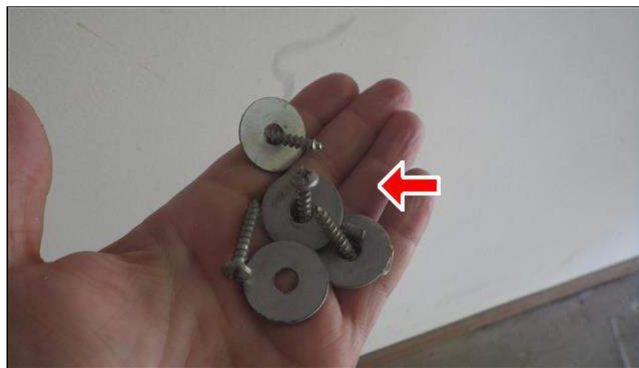
- 7.0 SERVICE ENTRANCE CONDUCTORS/SIZES
Comments: Inspected
- 7.1 SERVICE AND GROUNDING EQUIPMENT, MAIN OVERCURRENT DEVICE, MAIN AND DISTRIBUTION PANELS
Comments: Repair or Replace
(1) Screws that have pointed tips are in use at the electrical panel cover, which is not recommended as they can puncture wires. Have replaced with the correct screws by a qualified electrician.

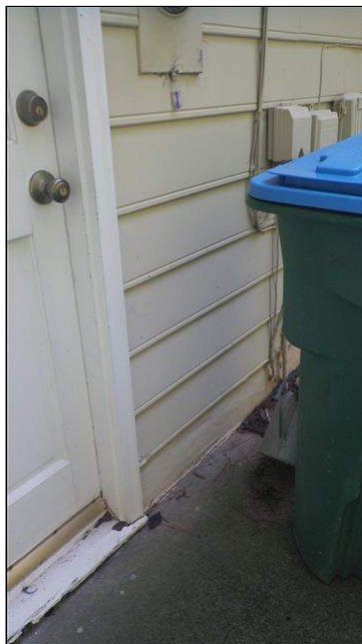
(2) I was unable to determine how the electrical system is grounded. Have grounding verified by a licensed electrician.

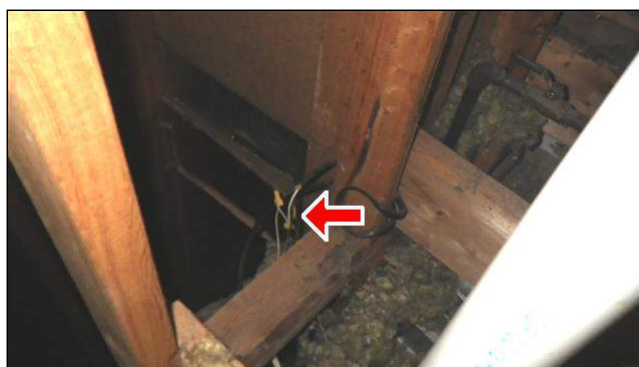
Exposed wires were observed inside the attic at the chimney chase.

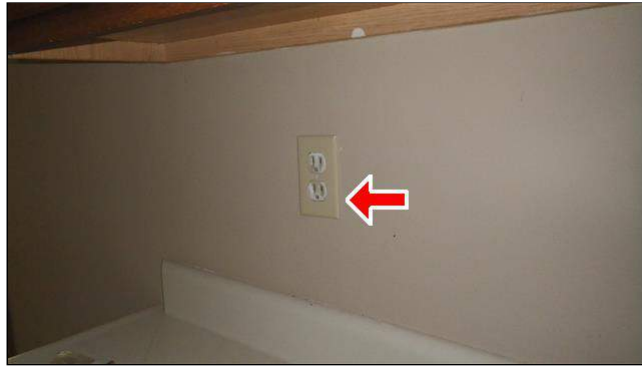
(1) The outlet to the left of the kitchen sink is a little loose.

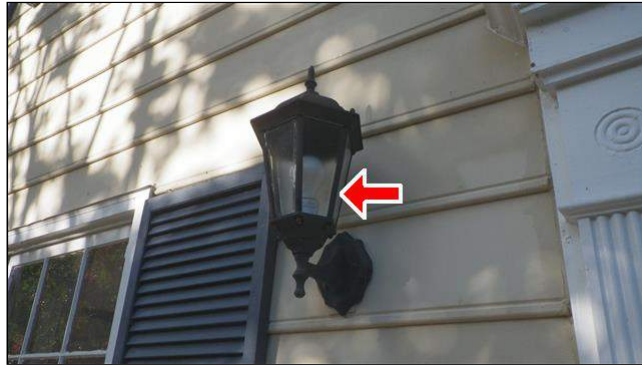
Example, front

(2) Have all burnt out or missing light bulbs in and around the house replaced where needed.

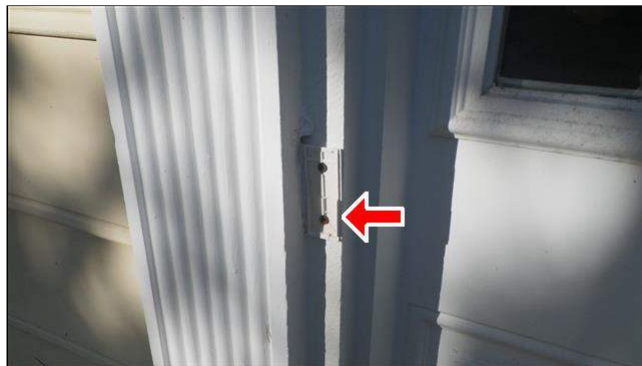
(3) There is not doorbell.

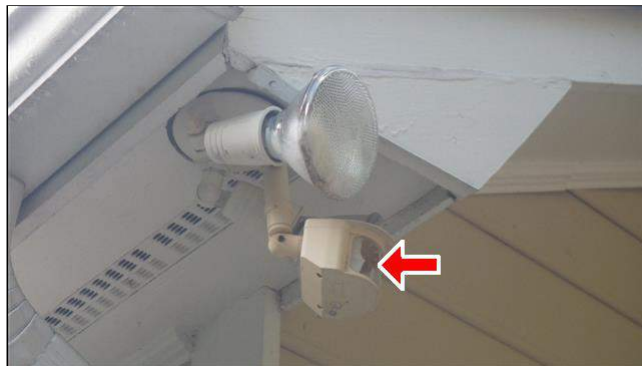
(4) The motion sensor covering is damaged at the exterior garage flood. This fixture is not tested as part of the inspection.

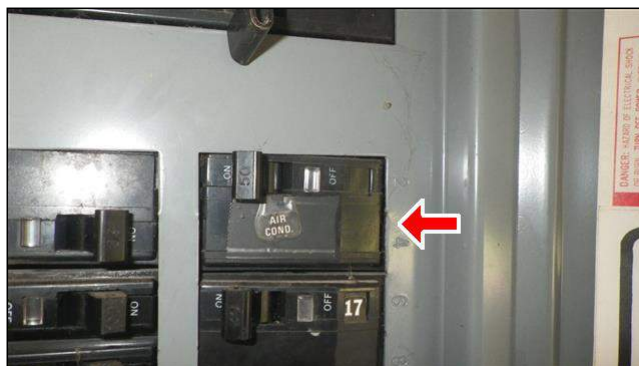
(5) The A/C condensing unit is over-amped. The manufacturer recommends it be connected to a maximum 45 amp breaker when it appears to be connected to a 50 amp one. This may cause damage to the unit by not tripping when needed and should be evaluated and repaired by a qualified electrician.

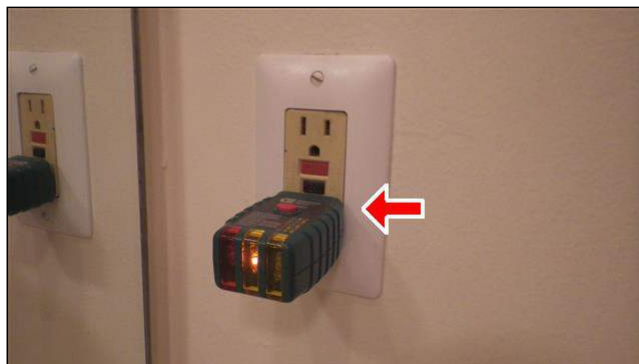
The guest bathroom GFCI outlet is showing an open ground. Although this will not impact the GFCI protection, a ground wire is recommended and should be further evaluated and repaired by a qualified electrician.

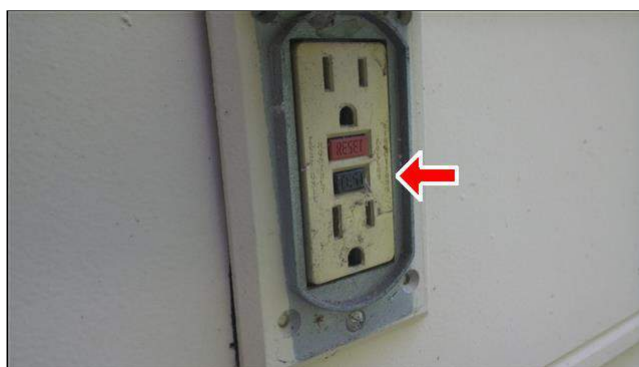
(1) The back exterior GFCI outlet no longer trips when tested, indicating that the GFCI protection is no longer operational and posing an increased safety risk. The outlet should be replaced.

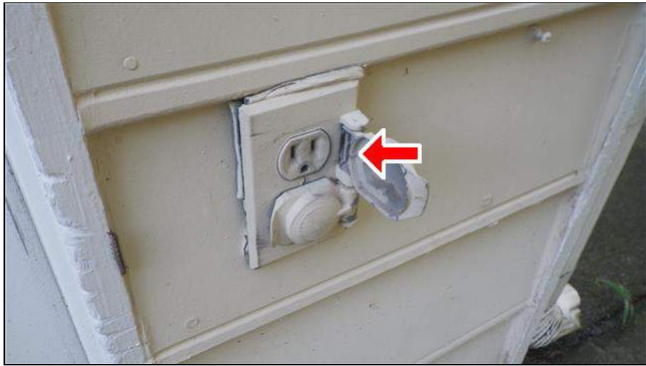
(2) The side exterior outlet is lacking GFCI protection.

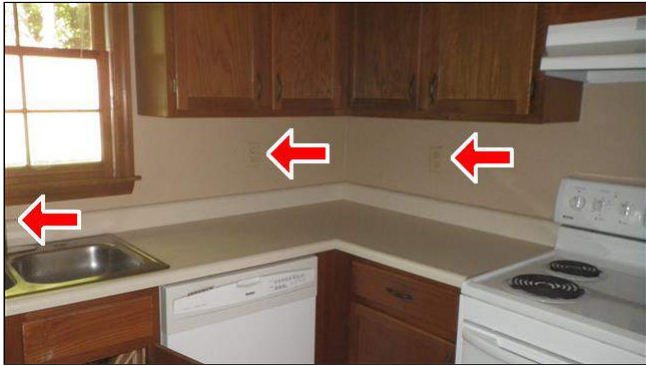
(3) GFCI protection is missing from the kitchen countertop outlets by the sink.

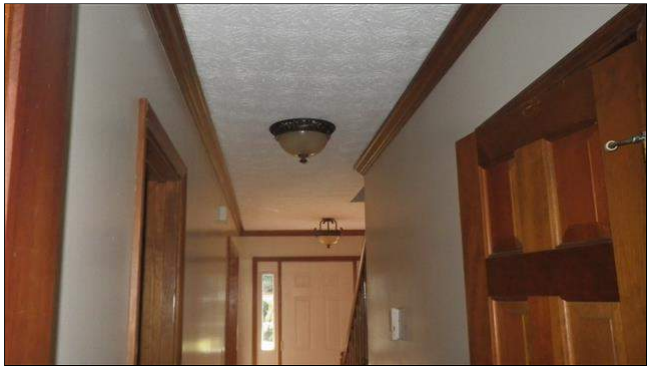
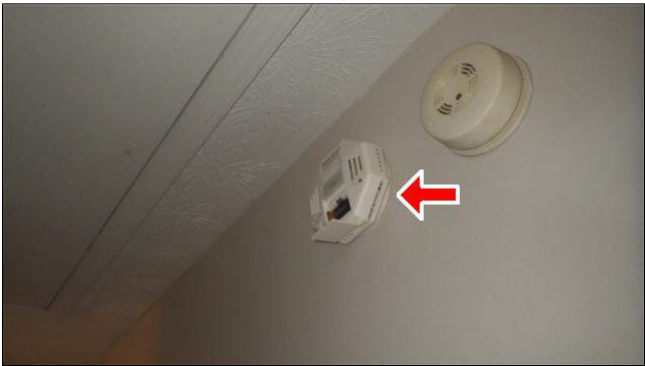
Comments: Repair or Replace
I did not locate a 1st floor smoke alarm. And the 2nd floor one needs a new battery.

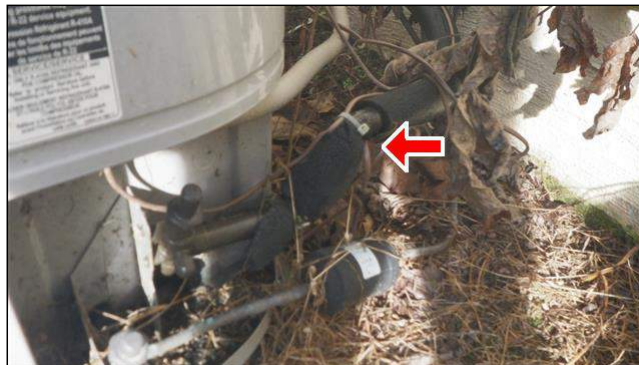
(1) Insulation is needed at the exterior suction lines where the existing insulation is missing or worn.

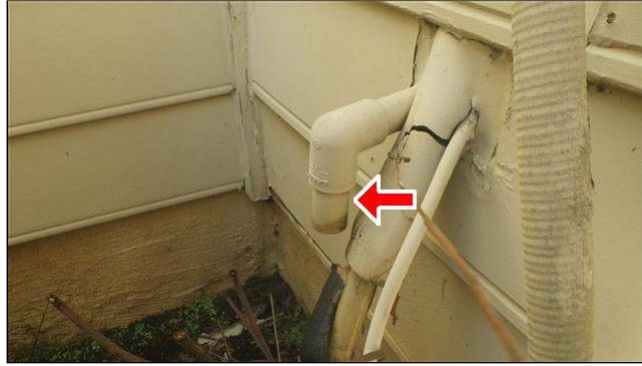
(2) Exterior condensate drains should be extended out to drain farther away from the house.

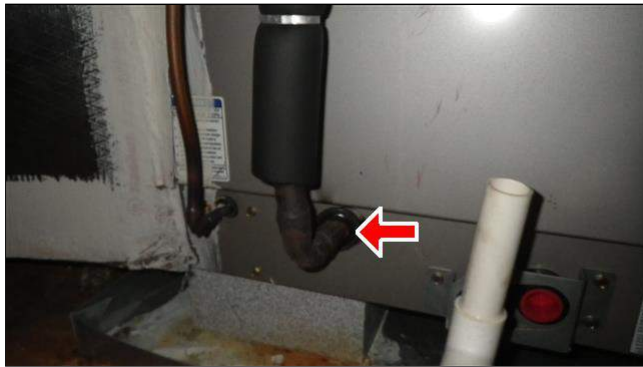
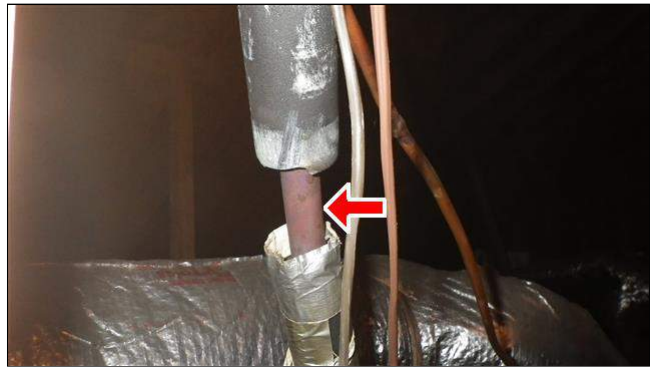
(3) Insulation is missing on sections of the A/C suction line inside the attic, causing condensation to form and drip onto the attic floor. This in turn can cause moisture stains on the ceiling below. Have additional insulation added by a qualified HVAC professional.

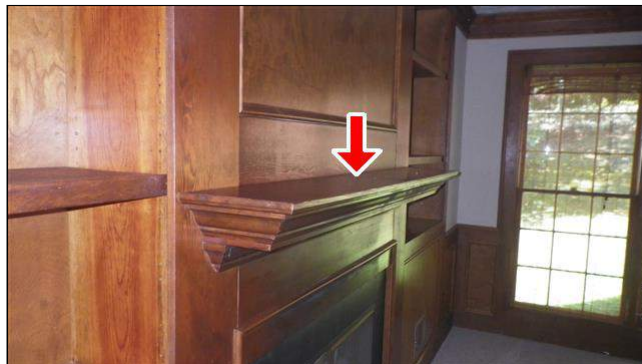
The fireplace mantle is not adequately secured to hold heavy objects.

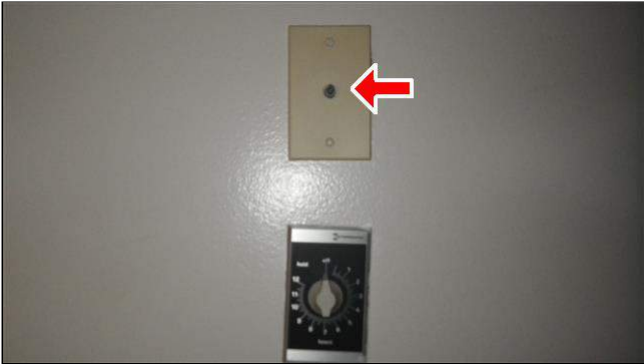
(1) The whole house fan in the 2nd floor hallway has a control knob missing and the control feels broken.

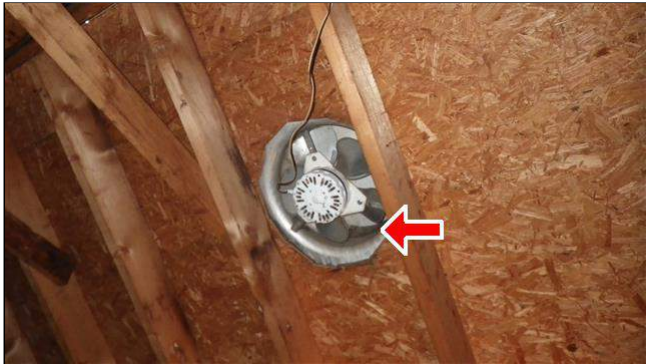
(2) A thermostat controlled vent fan was present in the attic but could not be tested, but is likely not operable. This can be addressed when the roof is replaced.

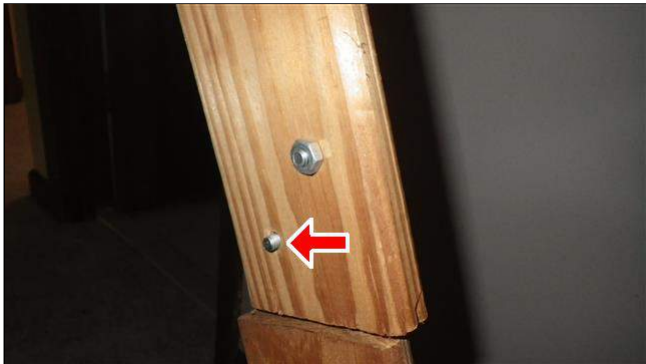
A nut is missing to a bolt fastener at the attic pulldown ladder.

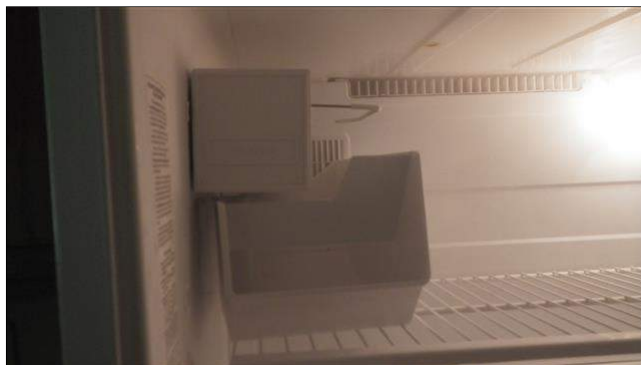
The ice maker was off at the time of the inspection, so I was unable to verify it is working.

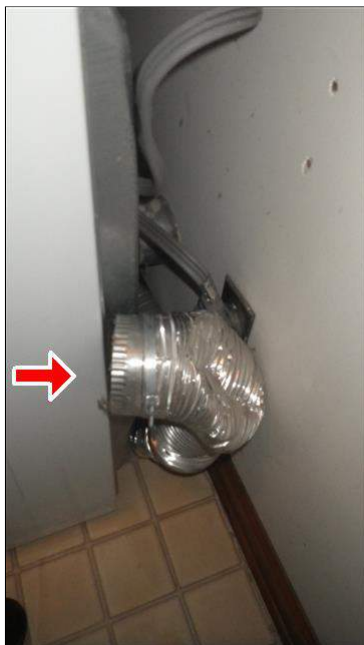
The dryer vent is loose in the laundry room.
