Inspection Report

Property Address:
4742 Union Hill Road
Canton GA 30115

Dana Home Inspections, Inc.

Date: 11/3/2016**Property:**4742 Union Hill Road
Canton GA 30115**Customer:**

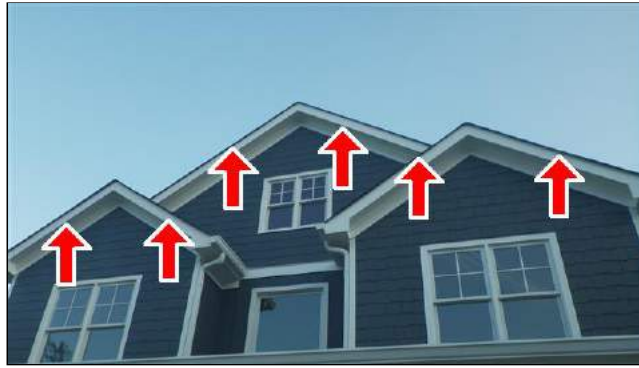
(1) Drip edges have not been installed at eaves and gables of the shingled roofs. Location requirements also include the builder's gaps behind all gutters.

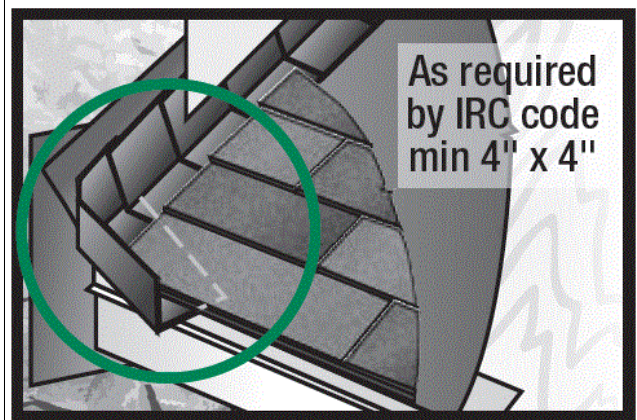
Front sidewall, example

(2) At all sidewalls around the house, the flashing was not installed to divert water into the gutter or away from the house. Have reviewed and corrected where needed.

Kickout Flashing

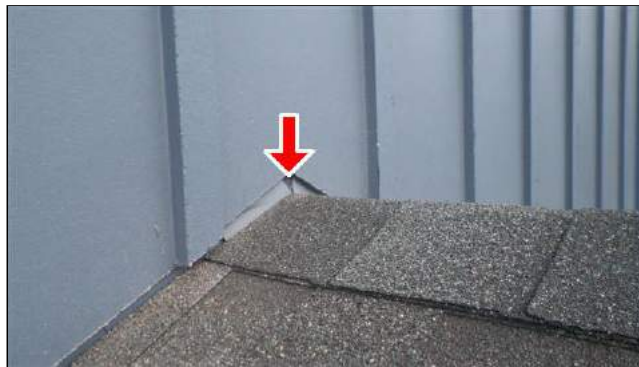
(3) At the breezeway roof between the garage and house, flashing was not installed completely where a gap was observed.

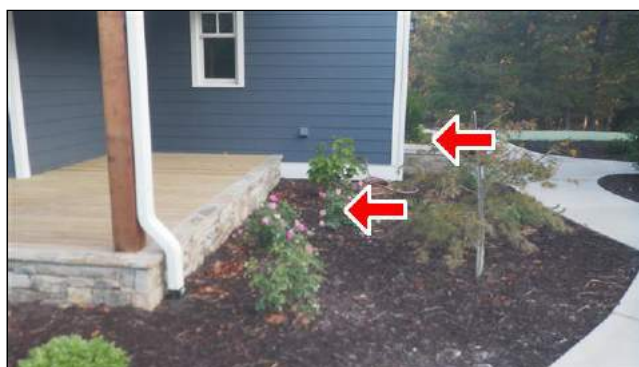
There is an inadequate grade for drainage at the right side of the house. The grade should fall away from the house a minimum of 6 inches within the first 10 feet.

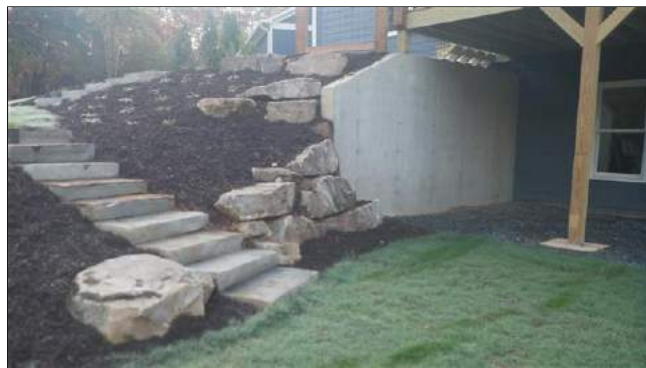
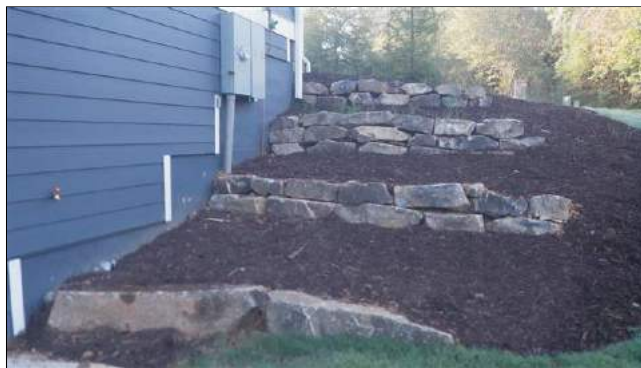
I was unable to locate the termination points of either of the foundation drains.

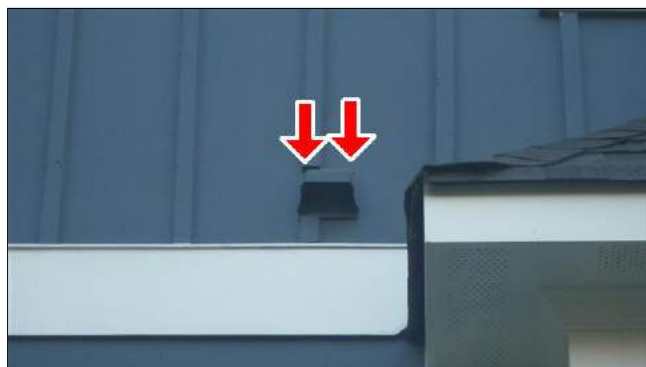
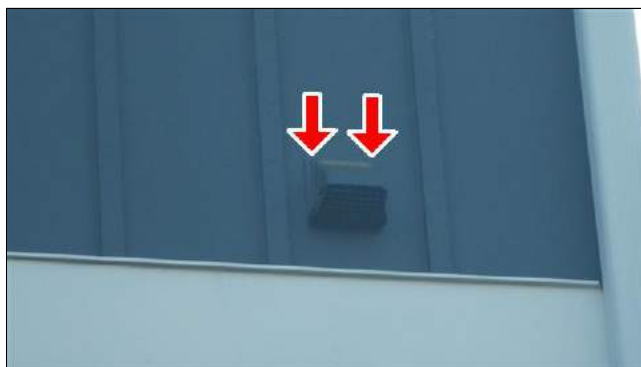
All plastic vent hoods at the exterior should be secured tightly to the siding with mechanical fasteners using the available holes. Any gaps between the component and siding should also be caulked.

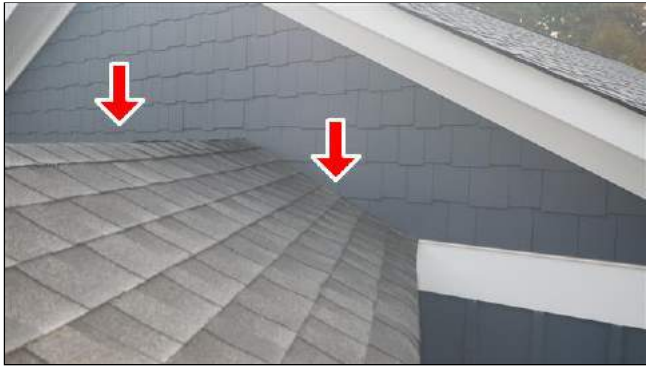
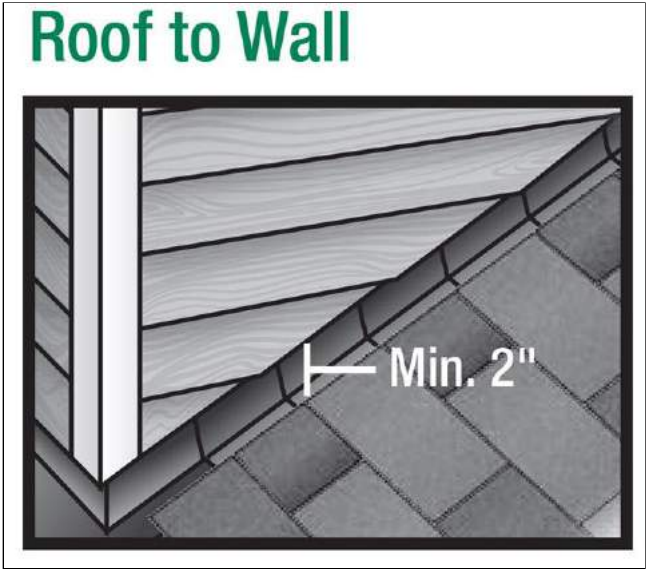
(1) Above the breezeway between the house and garage, siding was installed in contact with the roof shingles instead of having the minimum 2" clearance.

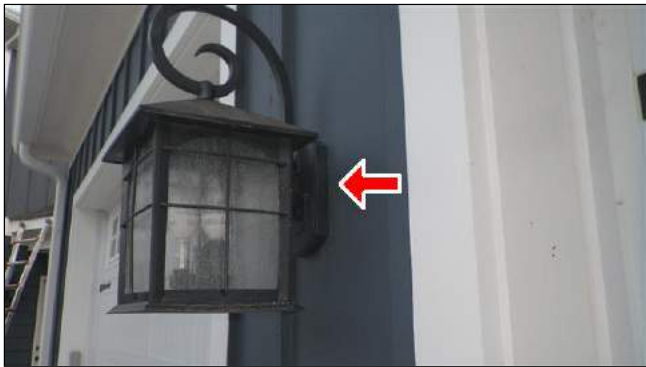
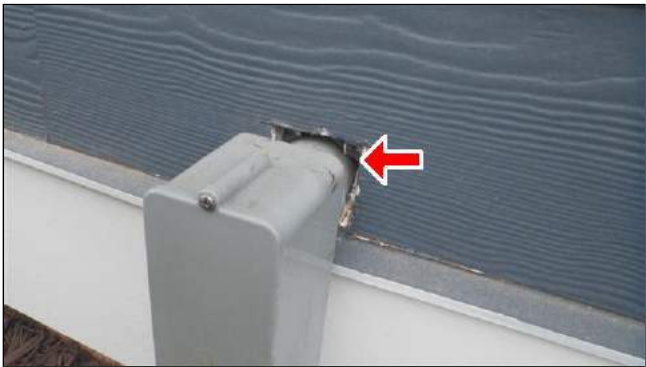
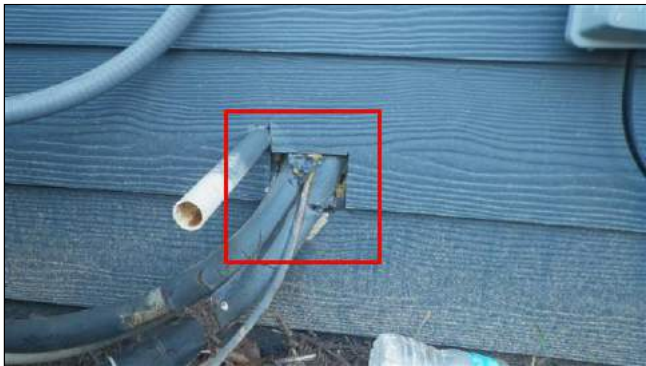
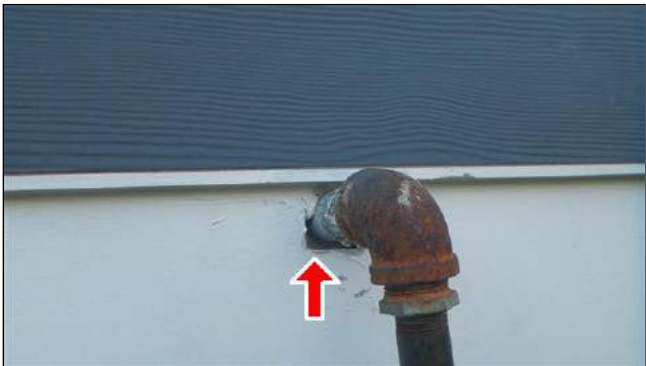
(2) All exterior penetrations into the siding should be caulked to prevent moisture intrusion.

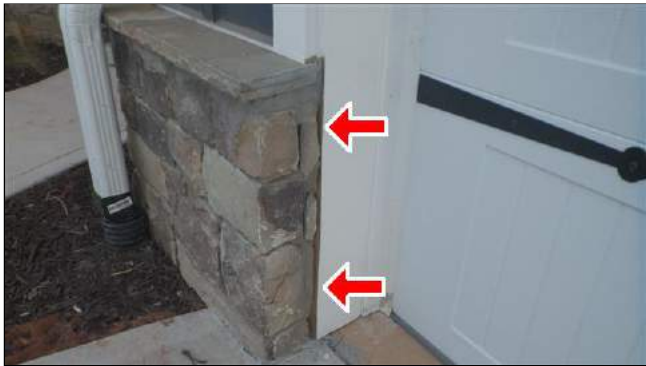
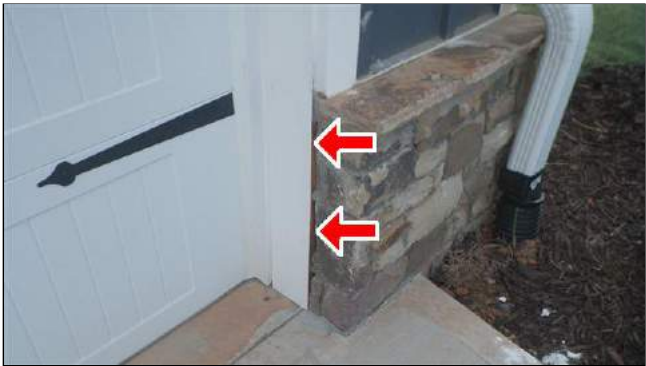
(3) At the stone along the front of the garage, a few areas of exposed unpainted trim was observed.

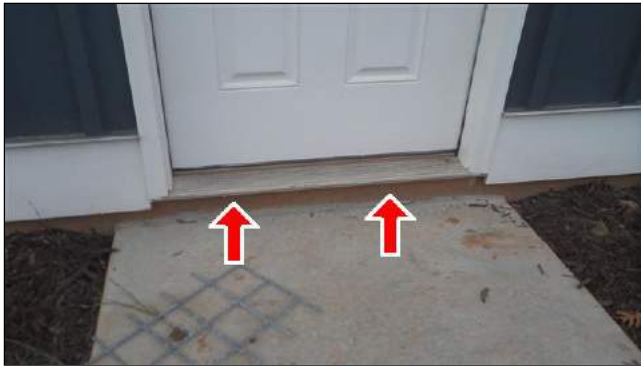
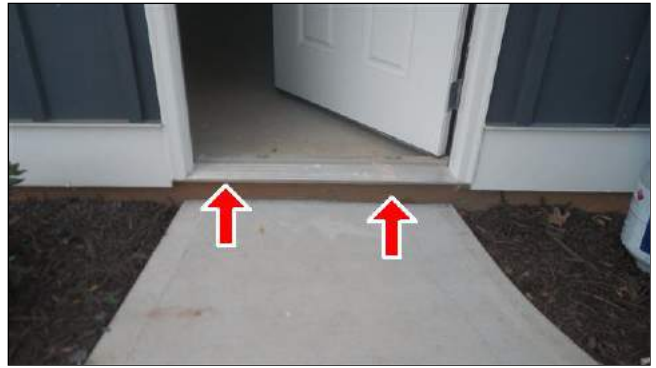
(4) All but two exterior doors are lacking pressure treated threshold supports.

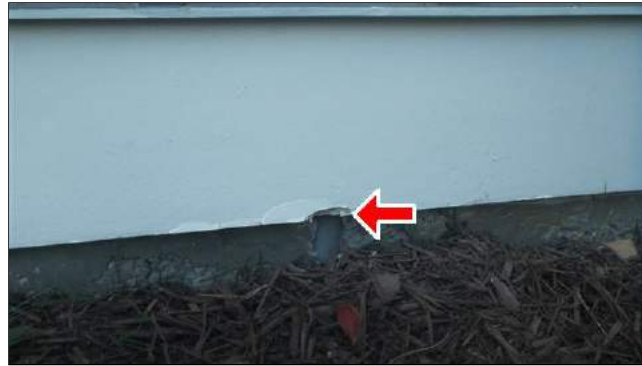
(5) A small area of damaged siding was observed at the left side of the garage.

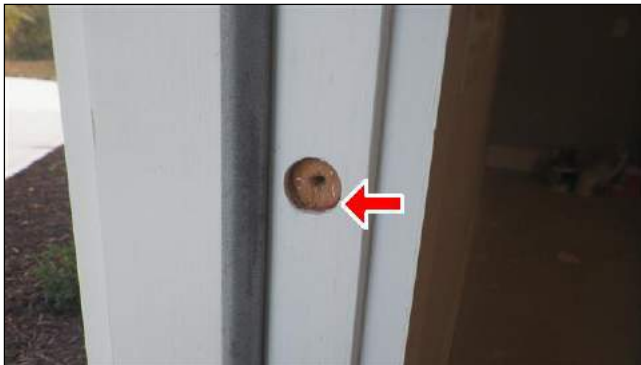
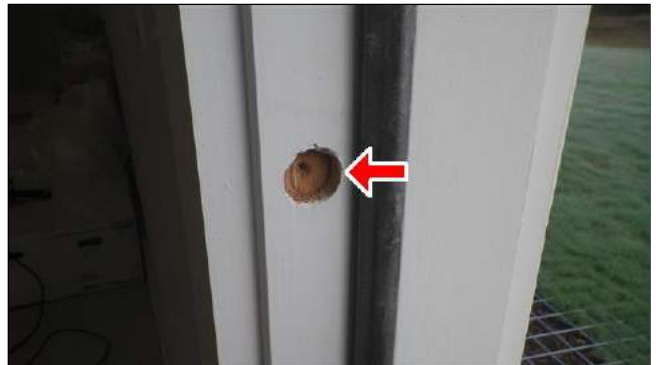
(6) Both exterior garage door deadbolts are lacking an adequate hole into the jamb as well as plates.

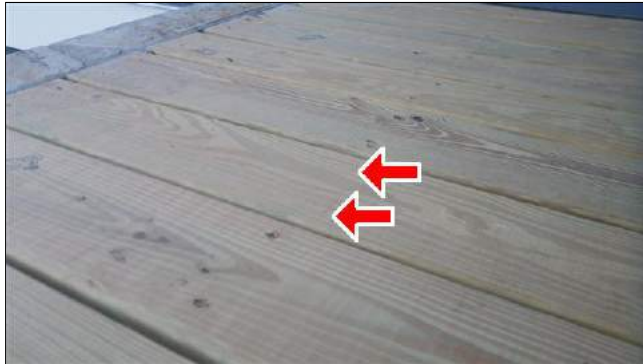
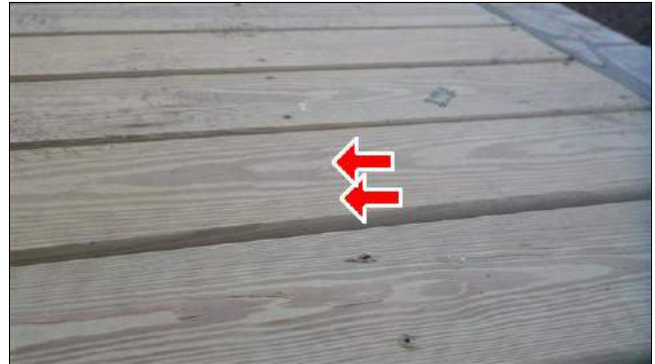
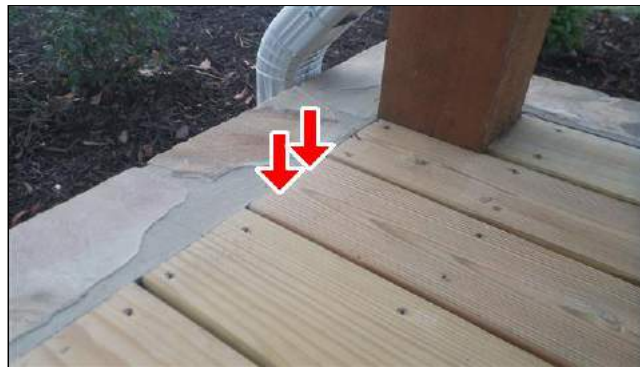
(1) Two sets of deck floor board screws are missing at the far left of the front porch. Another set is missing at the far right of the front porch.

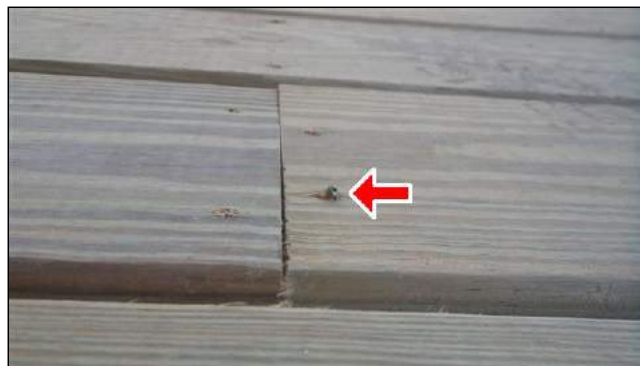
(2) On a floor board at the far left of the front porch, a screw head is sticking up.

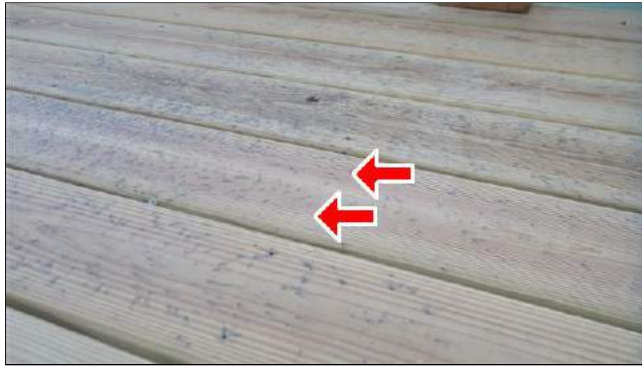
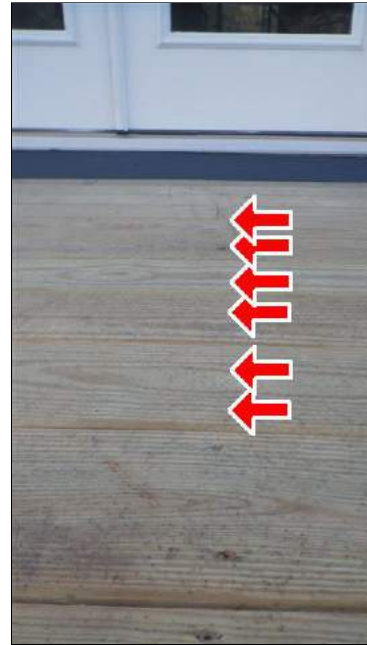
(3) Several sets of deck screws were missing at the back deck floor boards.

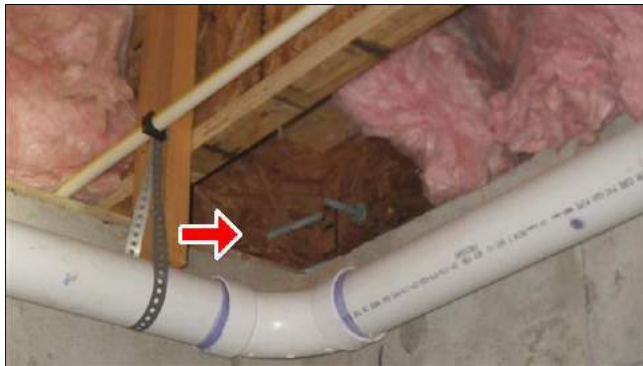
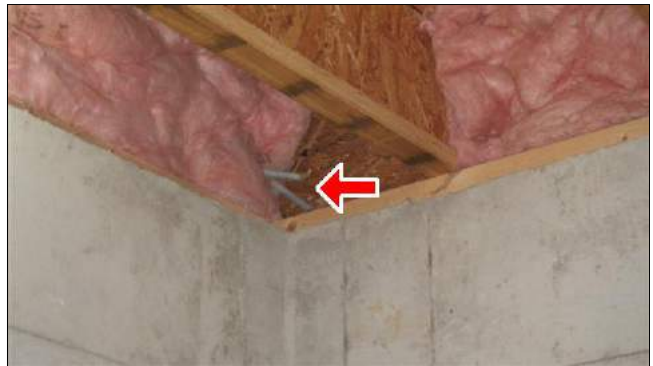
Inside the basement along the front wall rim board, some of the bolts securing the front porch are lacking washers and nuts. Have all of the bolts evaluated and secured as needed.

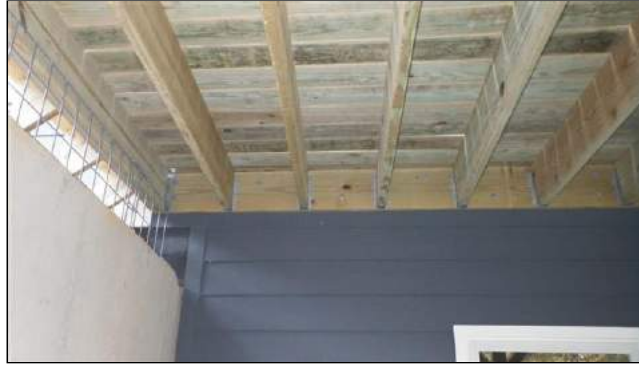
The deck was not built to the codes specified in the Georgia Deck amendment, but would not be required to be if the deck has been engineered. Contact the builder for more info.

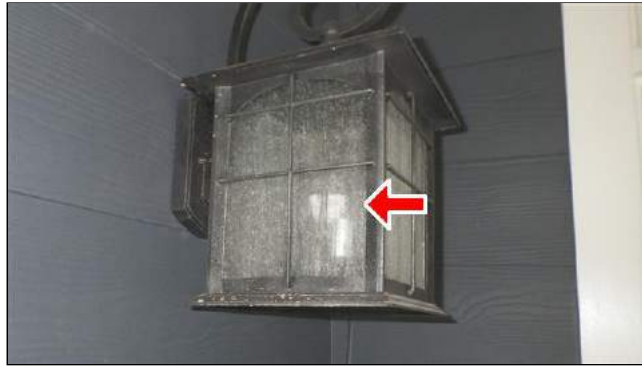
(1) Some of the front porch light fixture bulbs are missing.

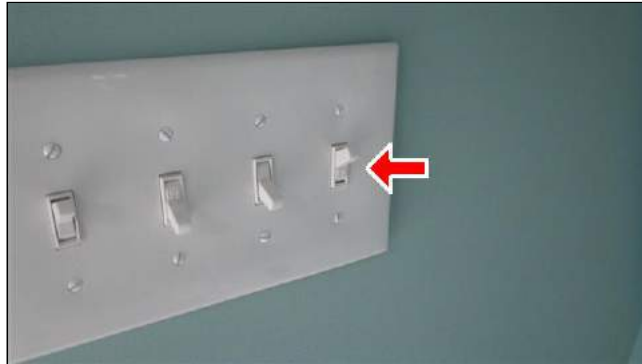
(2) I was unable to determine what one of the wall switches operate by the laundry room exterior door.

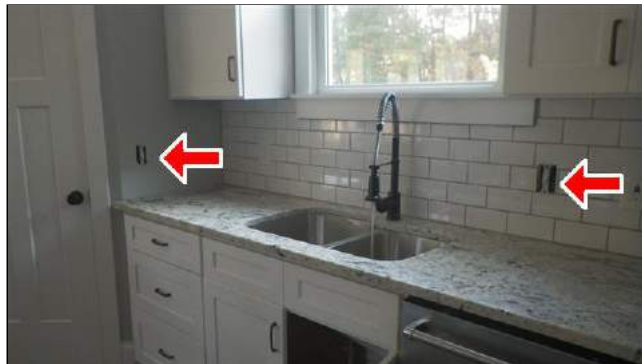
(3) Two switch plates are missing in the kitchen.

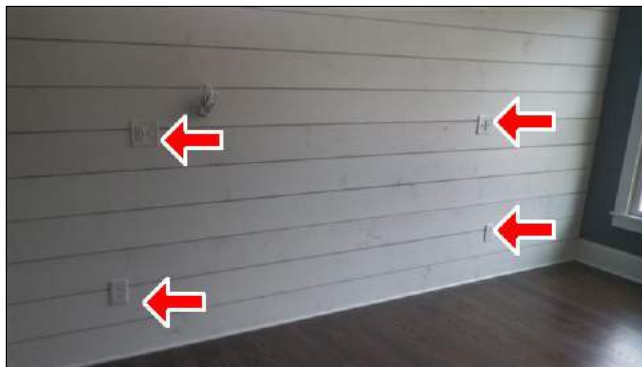
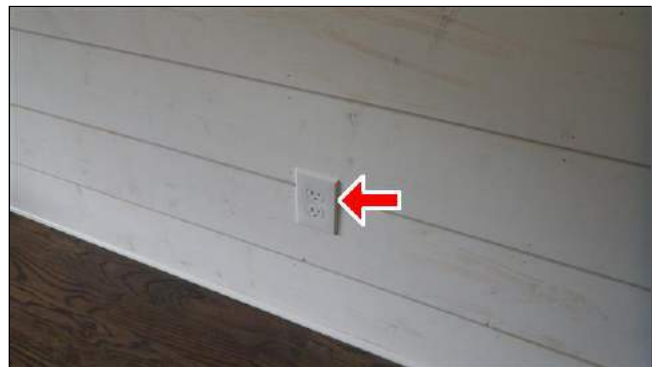
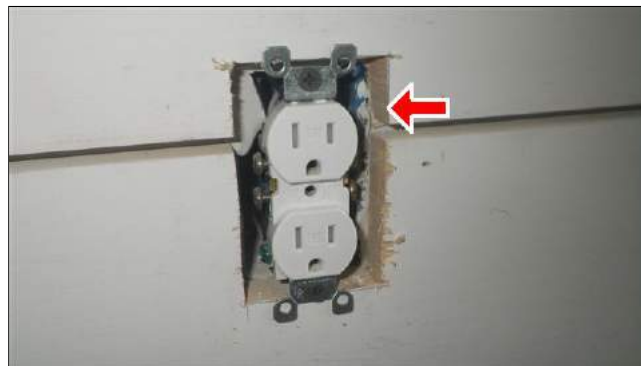
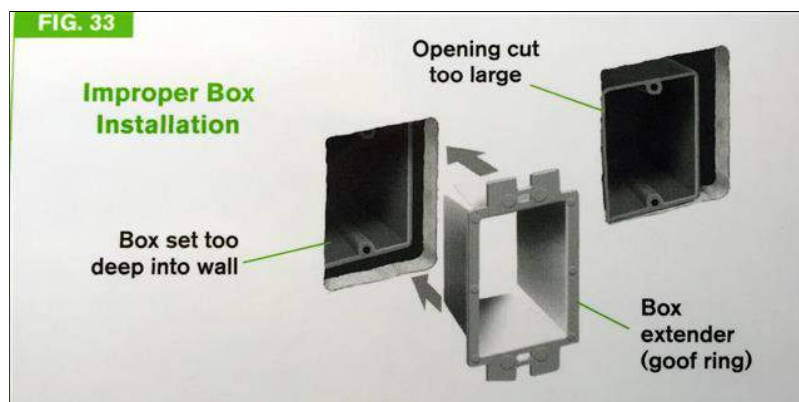
Inside the master bedroom and 1st floor office room where wood is in use as the wall covering, all of the outlet boxes are missing box extenders, causing a fire hazard.

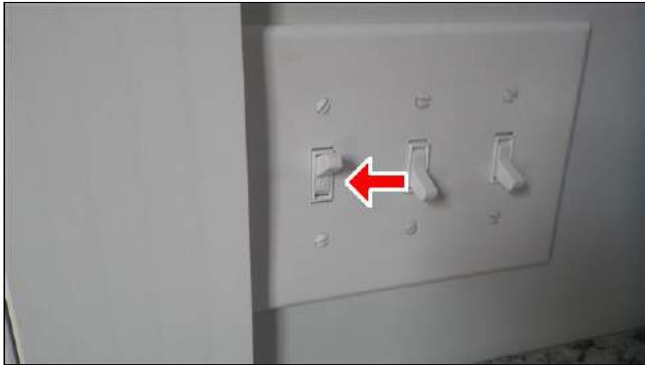
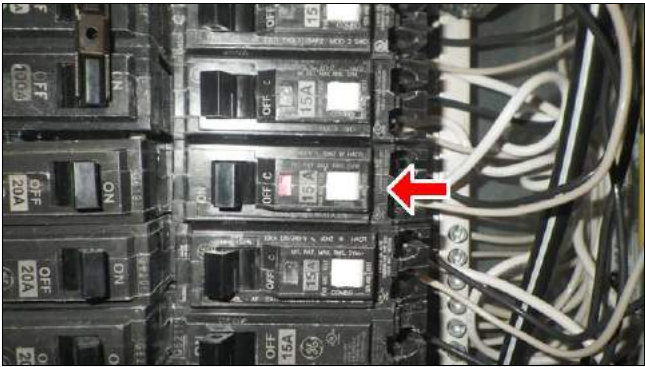
(1) Inside the 2nd floor left side Jack & Jill bathroom, the power was off at the breaker. After flipping the breaker back on, it tripped again when attempting to turn the bathroom fan on using the available switches.

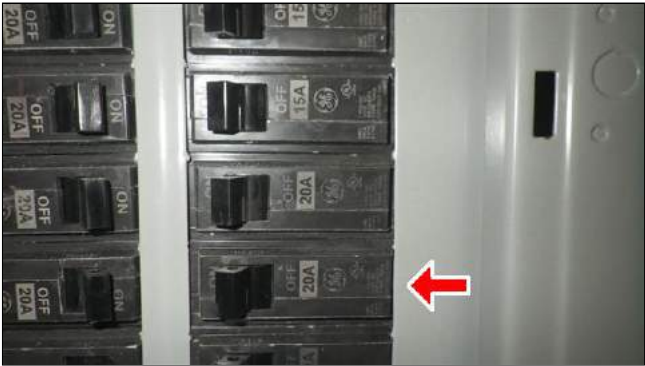
(2) Arc fault protection is missing on the laundry room circuit.

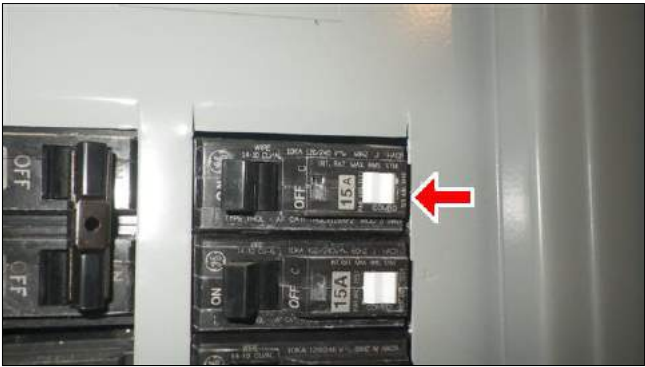
(3) Ground fault protection is missing at the dishwasher circuit.

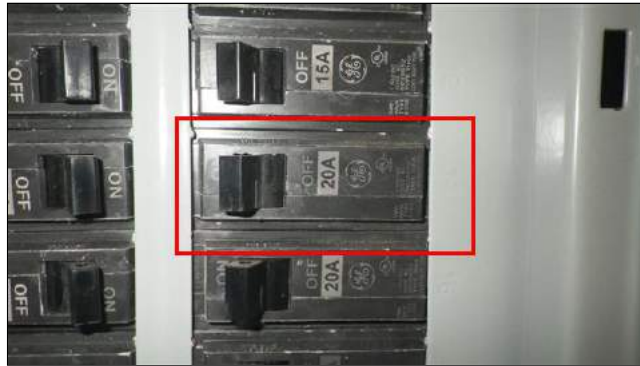
(4) Arc fault protection is missing at one of the kitchen circuits.

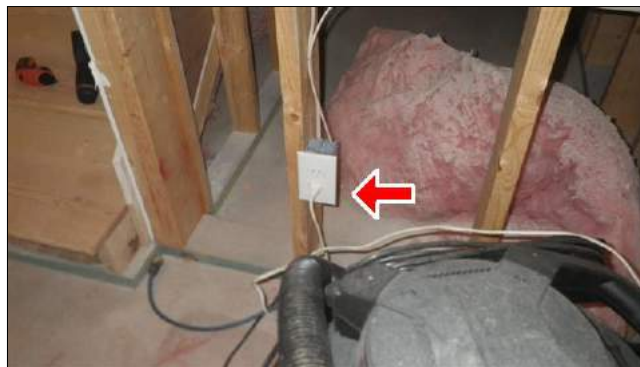
The outlet at the bottom of the basement staircase is lacking GFCI protection.

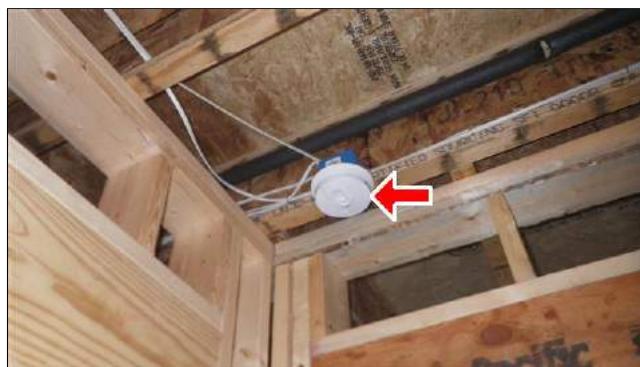
CO protection is missing in the basement.

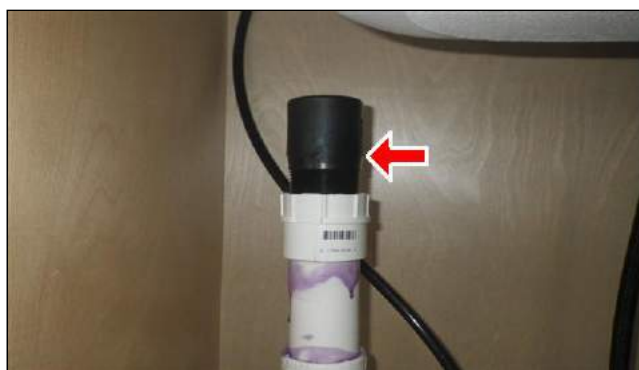
Laundry sink vent

Mechanical vents are in use for the air admittance valves inside some of the sink cabinets, but these are no longer approved for use in such locations.

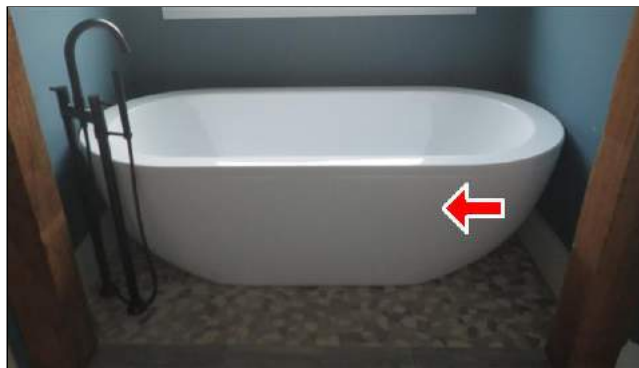
(1) The master tub is wobbly.

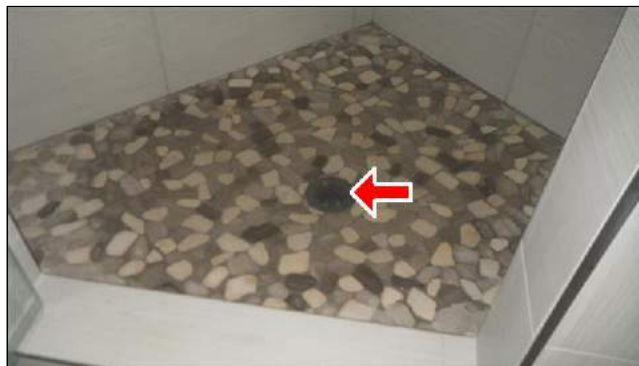
(2) The master shower drain is still plugged up from the pressure test.

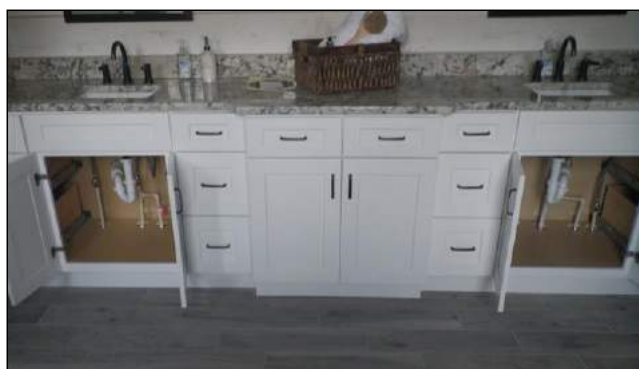
A mixing valve is missing in the master bathroom for the master tub. These are generally installed inside one of the sink cabinets.

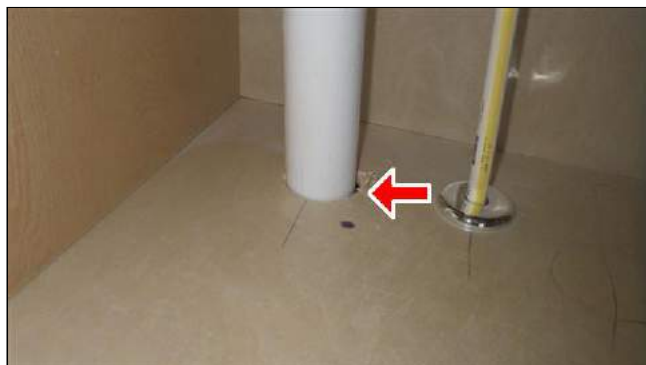
Example, laundry sink

Escutcheons are missing inside every sink cabinet for the drain pipe openings.

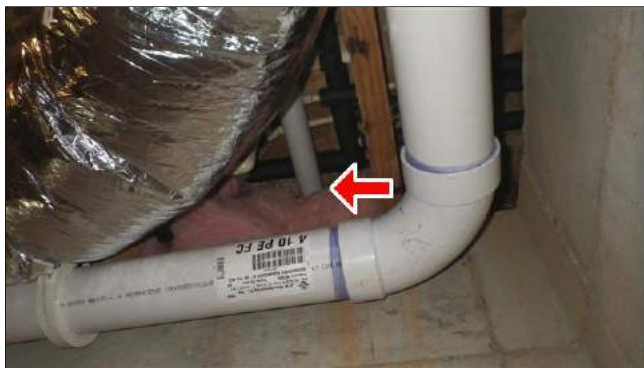
Basement view

The 1st floor furnace exhaust vent has not been terminated to the exterior and instead sounds as though it is behind the exterior laundry room steps.

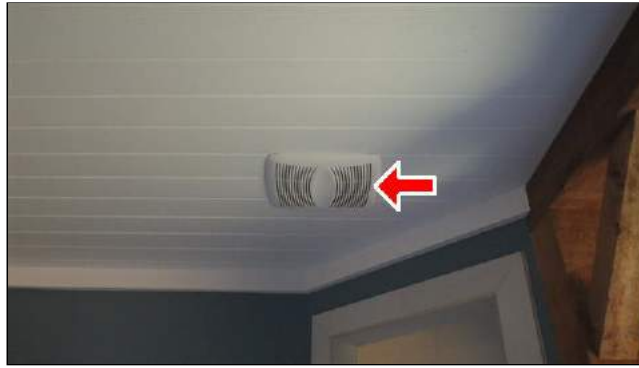
The master bath vent fan does not sound to be operating as expected, and sounds differently than the other fans.

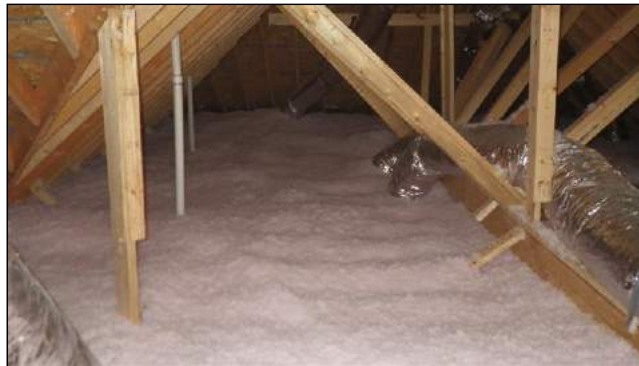
The attic may have not been installed by a licensed installer due to the fact that there are no insulation markers inside the attic, nor is there an insulation certificate present.

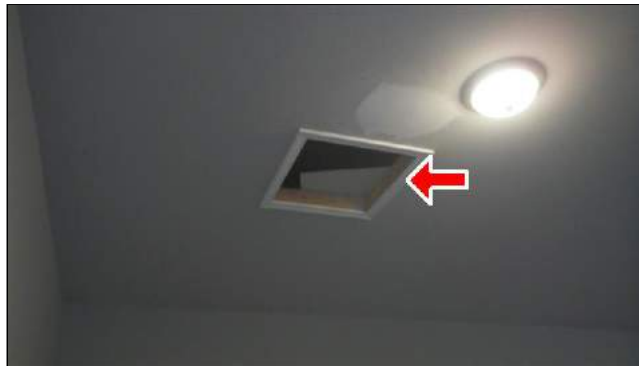
(1) Although not required, I am surprised that a pulldown ladder was not installed for the garage attic and only a scuttle hole was cut in. There is a large area above this that could be used for storage. There is also no flooring inside the attic.

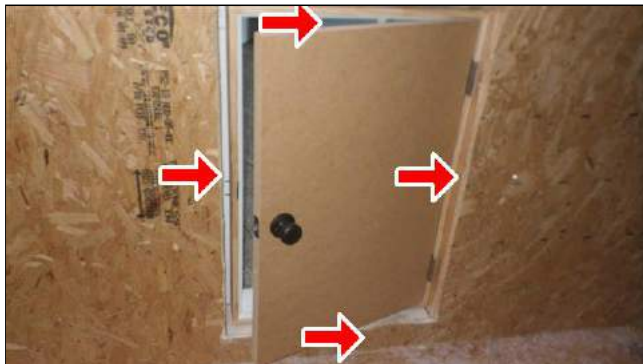
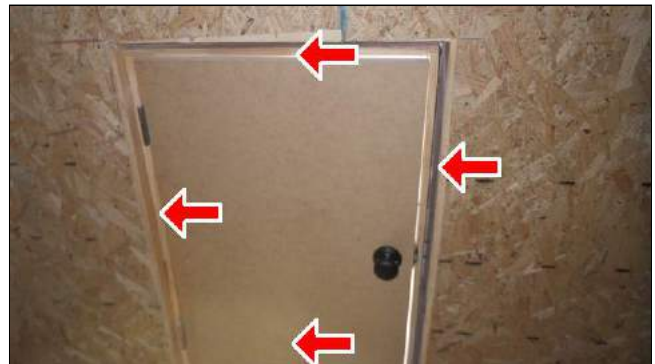
(2) Foam insulation is needed along jambs of the two small crawl in attic doors.

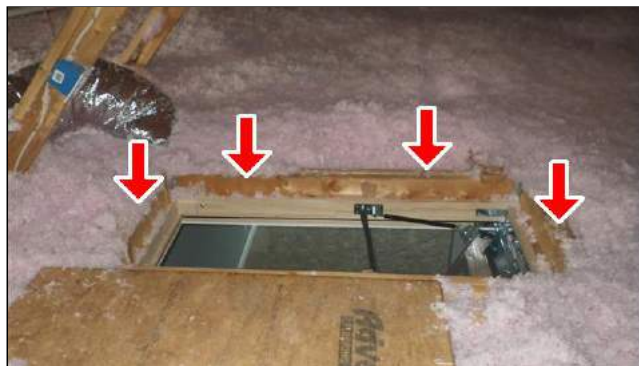
(3) A wood framed or equivalent baffle or retainer is missing at the attic opening, the purpose of which is to prevent the loose fill insulation from spilling into the living space when the attic access is opened, and to provide a permanent means of maintaining the installed R-value of the loose fill insulation.

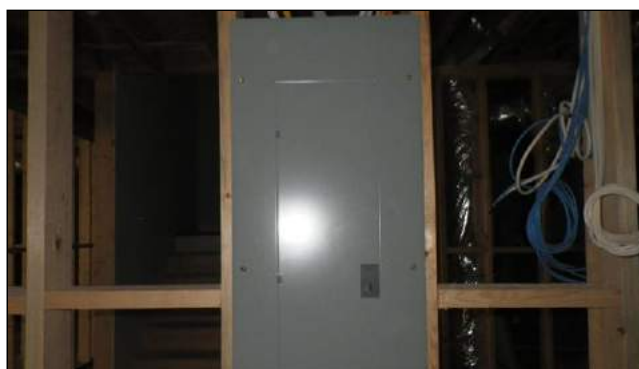
The energy certificate is missing from the electrical panel.

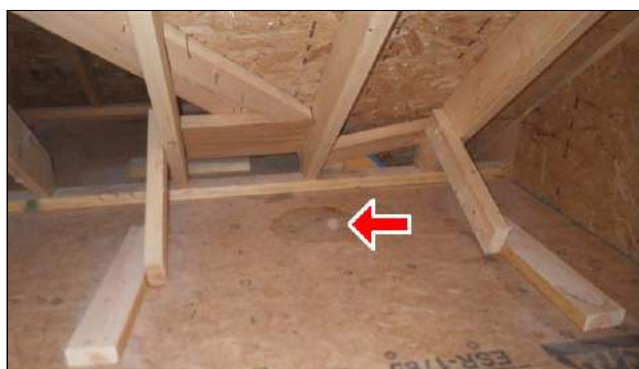
A small stain was observed on the attic floor above the master bedroom but appears old.

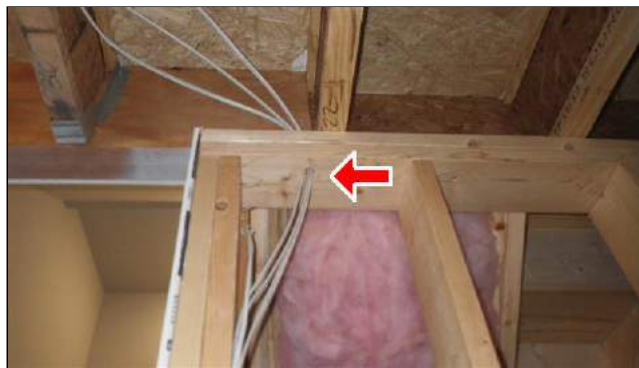
Fireblocking foam is missing at all top plate penetrations in the basement.

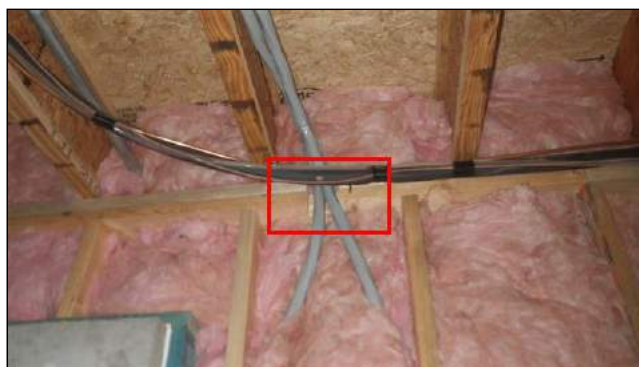
(1) A structural plate is required in the basement where the two electrical service wires go through the top of the wall. The notch is over 50% of the width of the plate, requiring a structural metal plate.

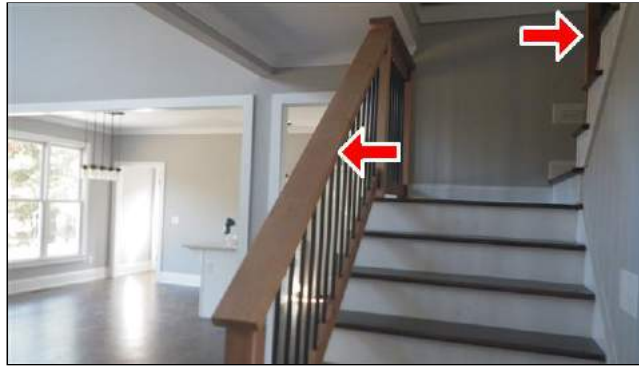
A gripable handrailing is missing at the two flights of stairs to the 2nd floor.

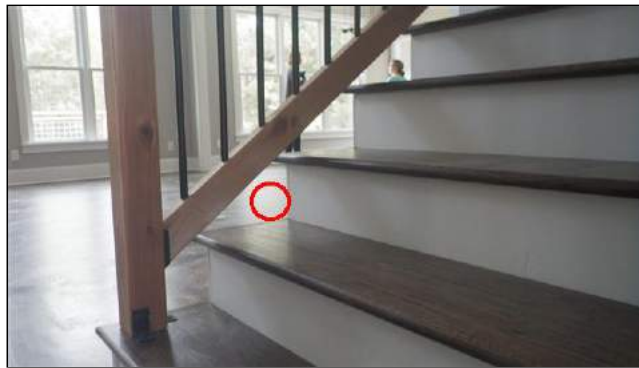
The 2nd floor staircase guard railings have triangular openings that allow a 6" sphere to pass.

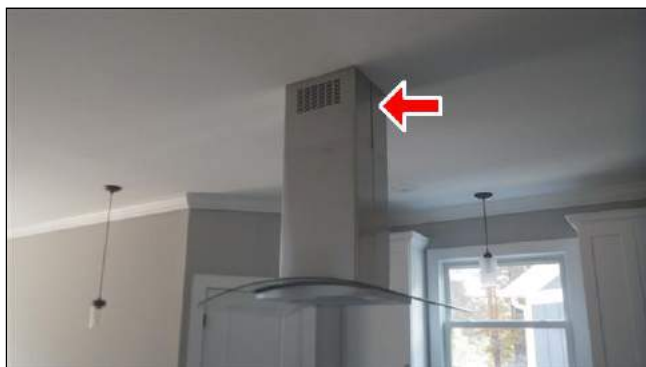
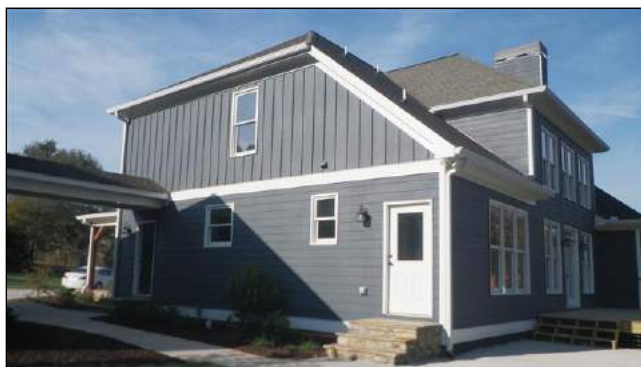
The kitchen vent hood is not vented to the exterior.

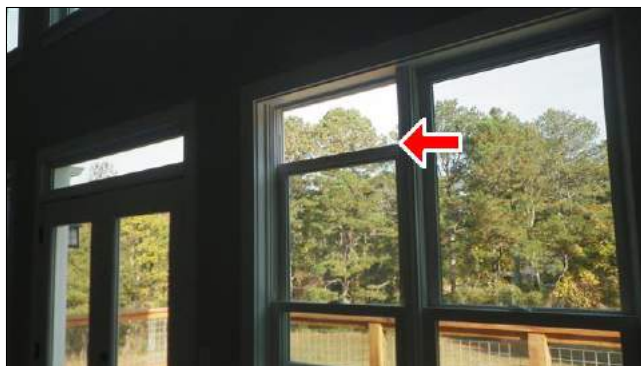
The upper sash at the back door falls open when the windows are unlatched.

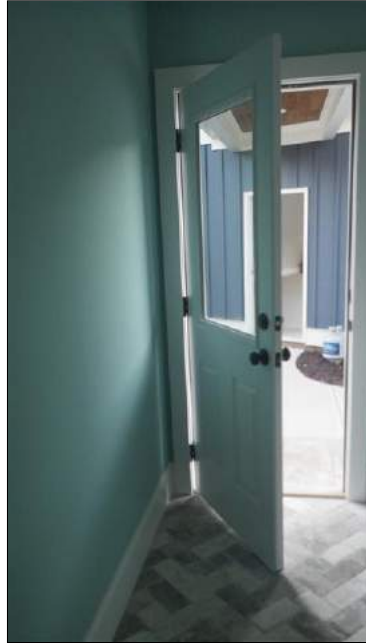
(1) Door stops are missing throughout the house.

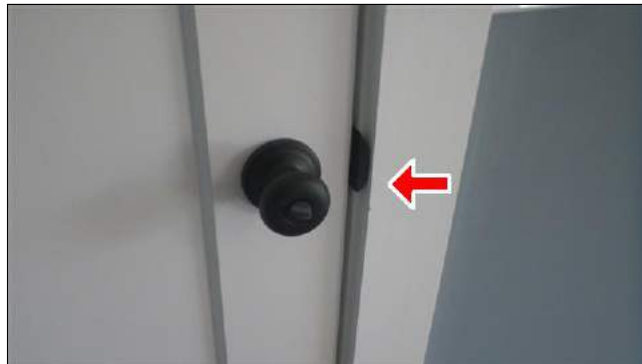
(2) The 2nd floor front left guest bedroom door does not latch shut.

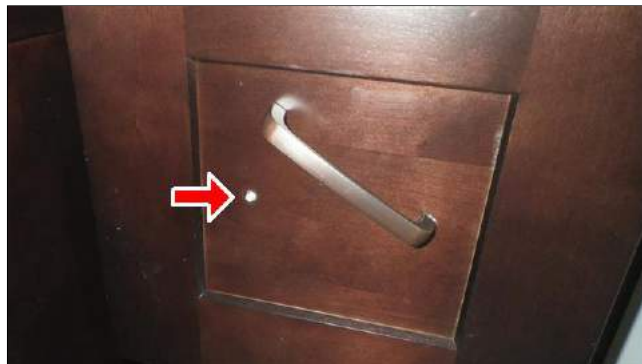
(3) Inside the 2nd floor right side Jack & Jill bathroom, one of the cabinet door pulls is loose.

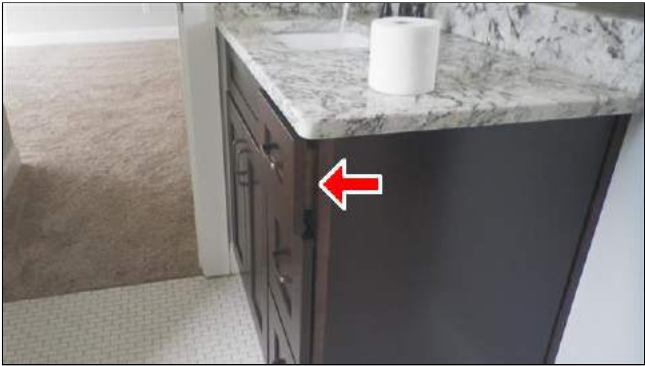
(4) Inside the 2nd floor right side Jack & Jill bathroom, one of the drawers does not fully close.

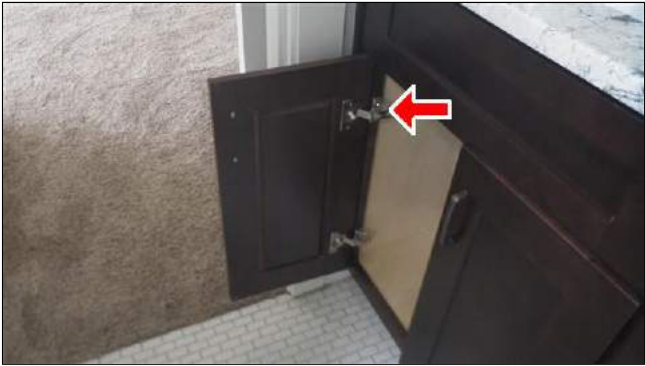
(5) Inside the 2nd floor right side Jack & Jill bathroom, one of the cabinet doors has a loose hinge.
