Pre Drywall Inspection Report

Seneca Lot 36
Cumming GA

10/28/2016

Dana Home Inspections, Inc.

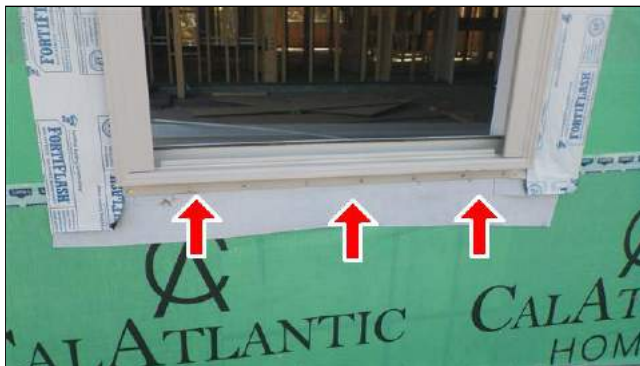
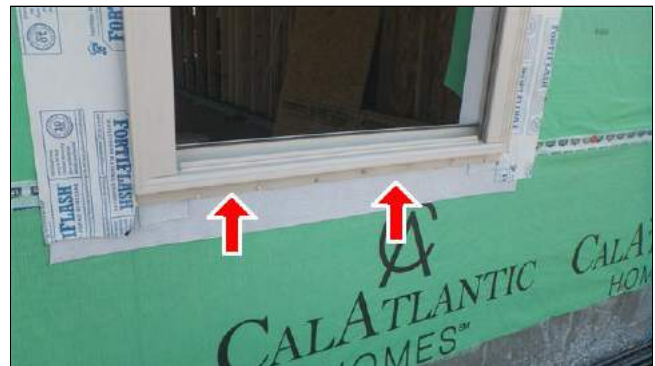
1.7 WINDOW INSTALLATION

1. Across all of the windows, the bottom nails fins have all of the nail holes filled, which is against the manufacturer's installation guidelines.

Across all of the windows, the bottom nails fins have all of the nail holes filled, which is against the manufacturer's installation guidelines.

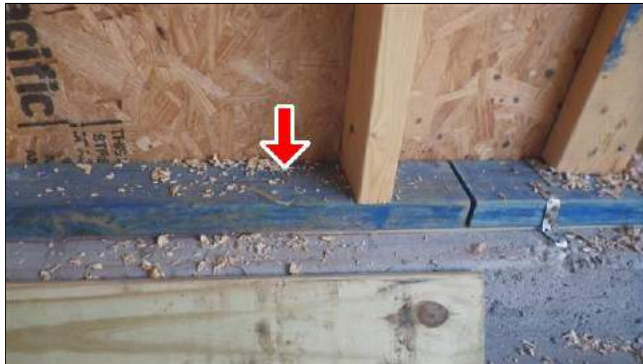
Garage, example

2. Several breaks in sill plates are lacking required foundation anchorage on one or more sides. Per IRC 403.1.6: "There shall be a minimum of two bolts per plate section with one bolt located not more than 12 inches...from each end of the plate section." Have the house reviewed and all areas secured where needed.

Several breaks in sill plates are lacking required foundation anchorage on one or more sides. Per IRC 403.1.6: "There shall be a minimum of two bolts per plate section with one bolt located not more than 12 inches...from each end of the plate section." Have the house reviewed and all areas secured where needed.

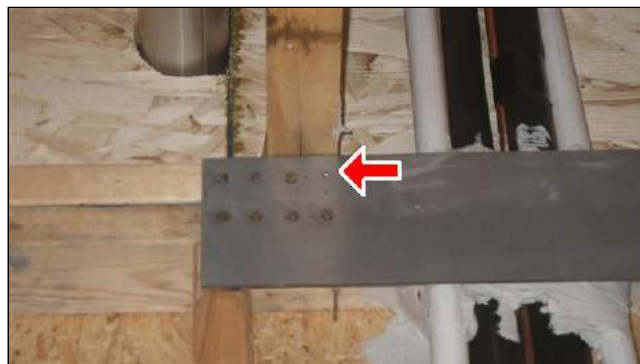
(1) At the structural plate on the 1st floor where the A/C line goes through the wall, all of the required nails have not been added in the available nail holes.

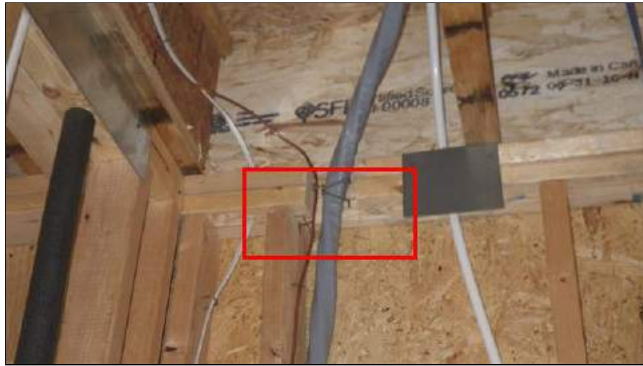
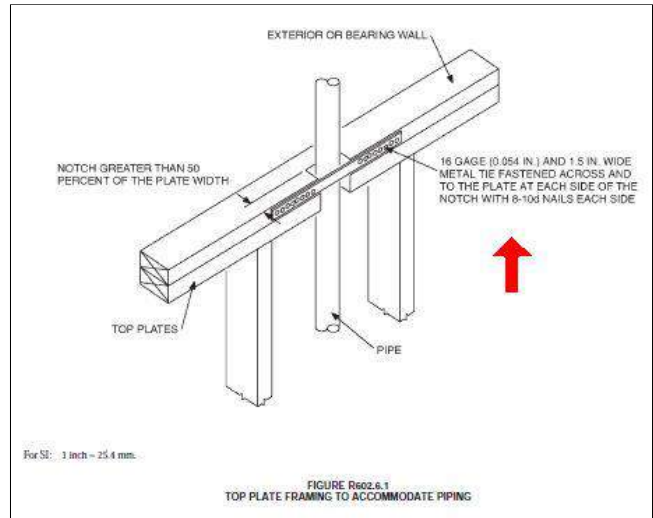
(2) A structural plate is required on the 1st floor where a large notch was made in the top plate for the main electrical service wire.

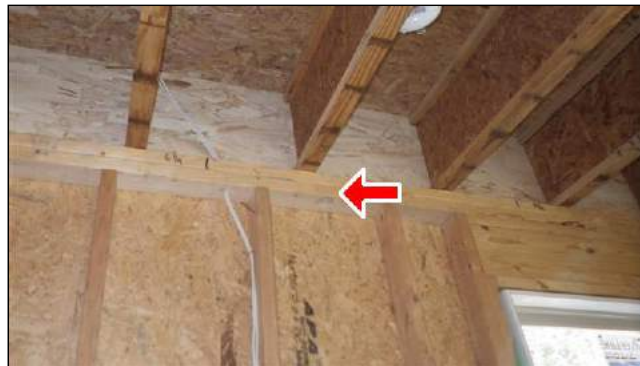
(3) A structural plate is required on the 1st floor where a large bored hole was made in the top plate for the main electrical service wire. The resulting hole in the wooden top plate is over 50% of the width of the plate, requiring a structural metal plate.

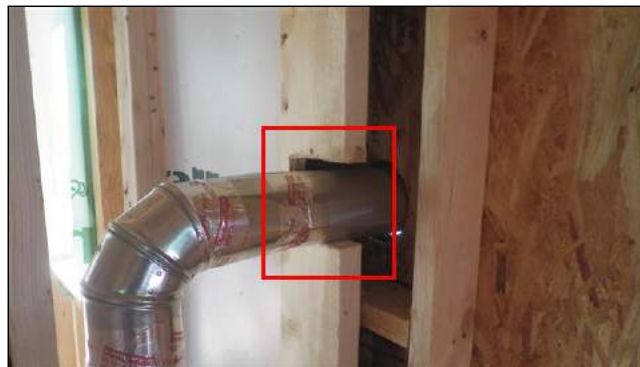
(4) Where a large notch was made in the stud in the laundry roof for the dryer vent, the stud now needs to be reinforced with a stud shoe or other approved means.

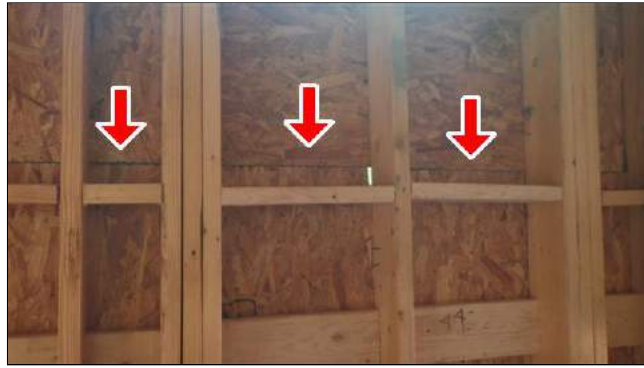
(1) Horizontal joints in the OSB sheathing lacking blocking in the 2nd floor stairwell.

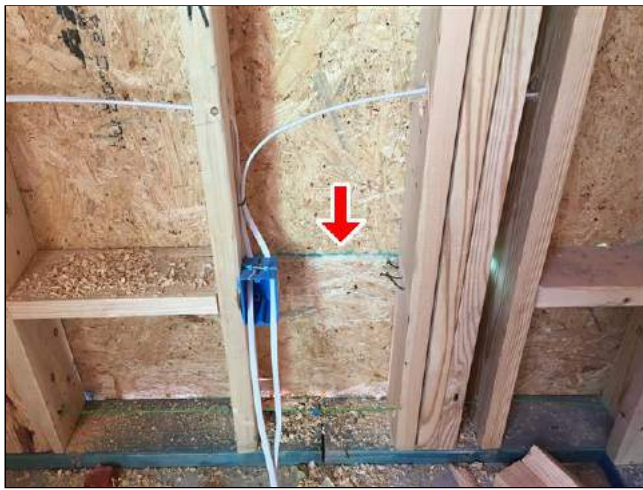
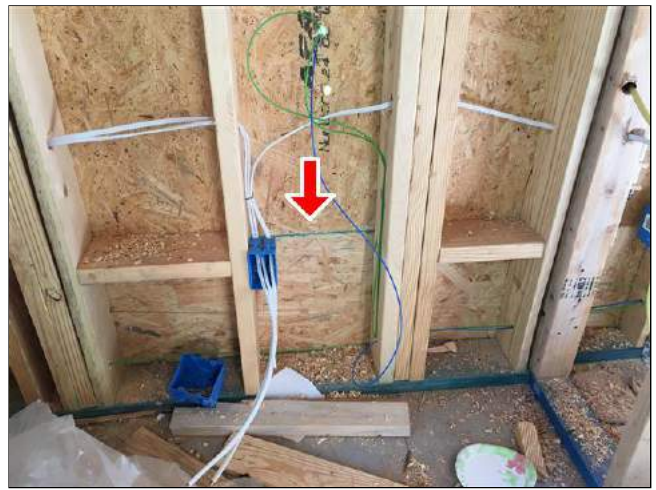
(2) Two horizontal joints in the OSB wall sheathing on both sides of the fireplace have had their blocking removed due to the installation of the outlets.

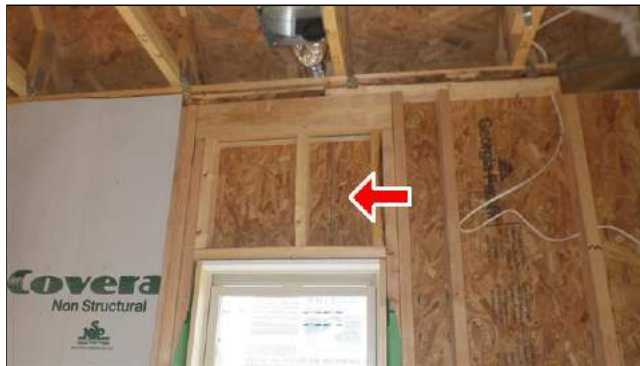
9. A vertical joint in the OSB board was not been blocked inside the 2nd floor right side bathroom.

A vertical joint in the OSB board was not been blocked inside the 2nd floor right side bathroom.

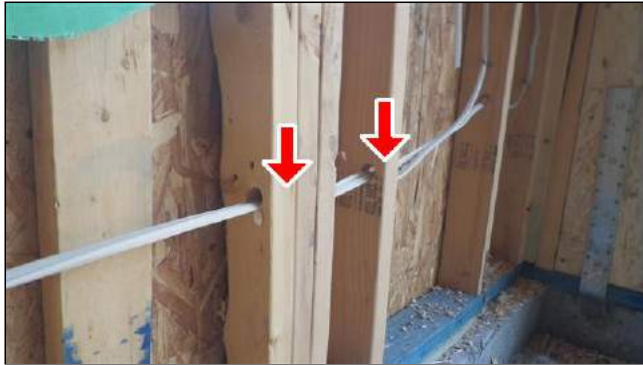
Sample area, garage

10. The final electrical county inspection does not appear to have been done as there were no nail plates anywhere in the house. Nail plates are needed where wiring was run too close to the end of studs. The wiring should be reviewed and nail plates added where wiring is less that 1-1/4" from the edge of the stud.

The final electrical county inspection does not appear to have been done as there were no nail plates anywhere in the house. Nail plates are needed where wiring was run too close to the end of studs. The wiring should be reviewed and nail plates added where wiring is less than 1-1/4" from the edge of the stud.

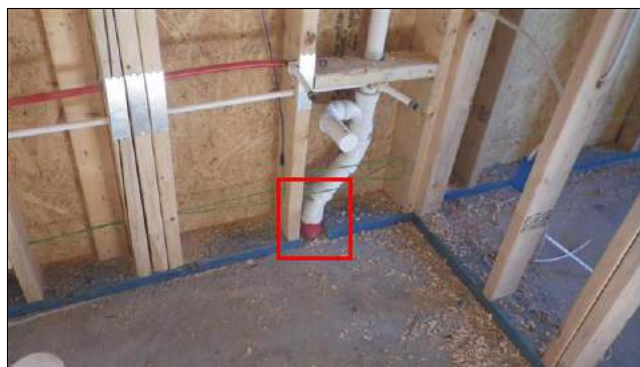
11. A protective plate is missing where the PVC drain pipe goes through the concrete in the 1st floor full bathroom.

A protective plate is missing where the PVC drain pipe goes through the concrete in the 1st floor full bathroom.

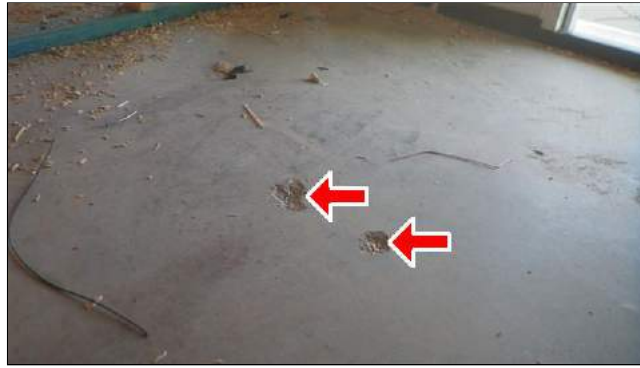
12. All pock marks in the concrete should be filled.

All pock marks in the concrete should be filled.

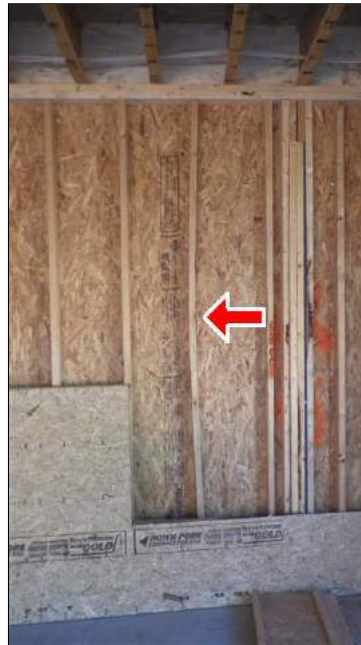
(1) A bowed stud was observed in the garage.

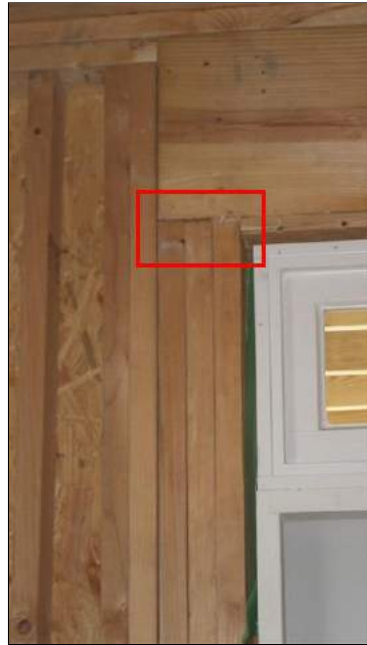
(2) Header-to-stud framing was not done tightly at the back door along the left side. Shims are needed.

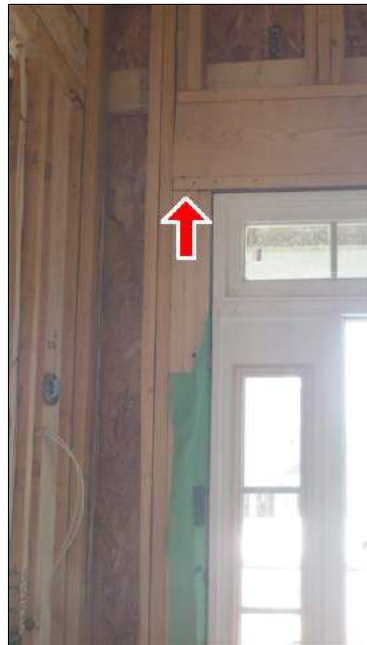
(3) Header-to-stud framing was not done tightly at the front door at the left side.

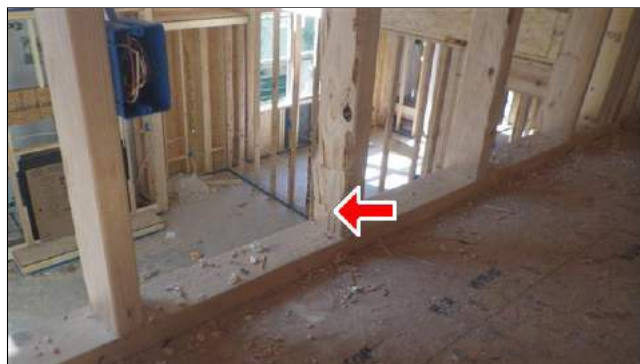
(4) Inside the master bedroom at the family room wall, the bottom of one of the studs is damaged.

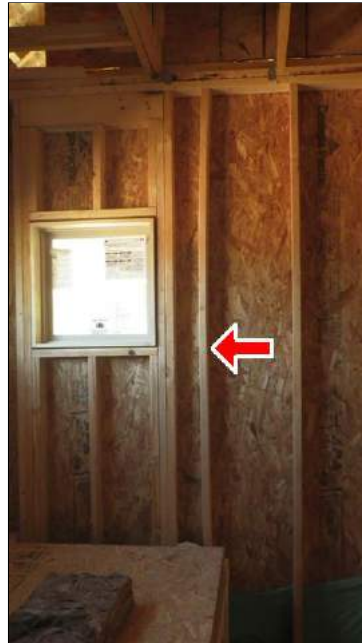
(5) A bowed stud was observed in the master bathroom next to the smaller window.

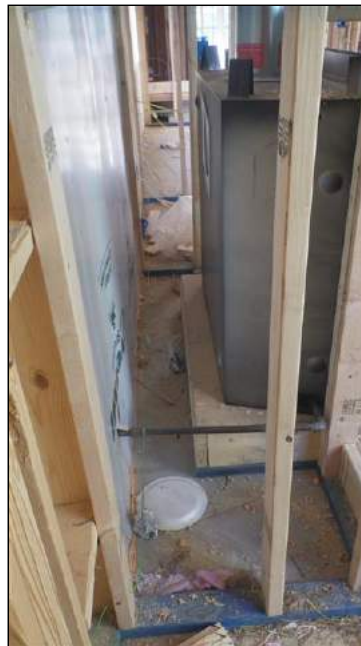
18. All debris on and around the fireplace should be removed.

All debris on and around the fireplace should be removed.

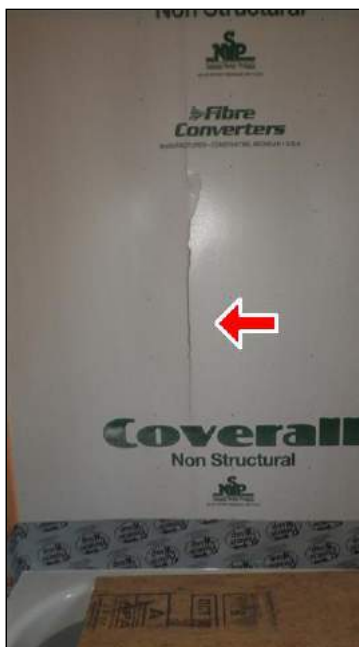
19. Inside the Jack & Jill bathroom, cracks in the thermo shield should be taped.

Inside the Jack & Jill bathroom, cracks in the thermo shield should be taped.

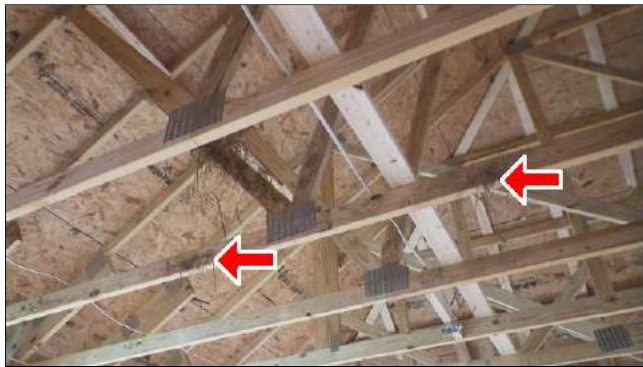
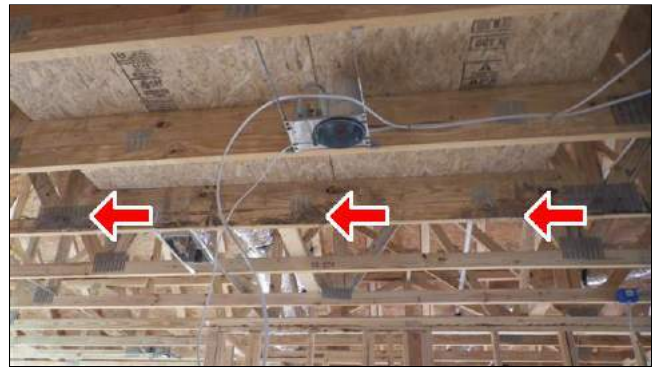
20. Straw debris on the trusses should be cleaned off.

Straw debris on the trusses should be cleaned off.

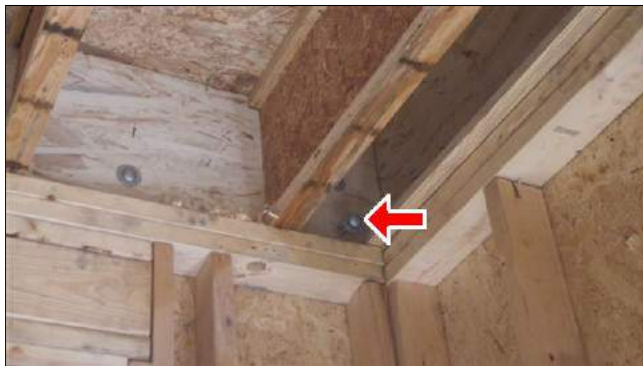
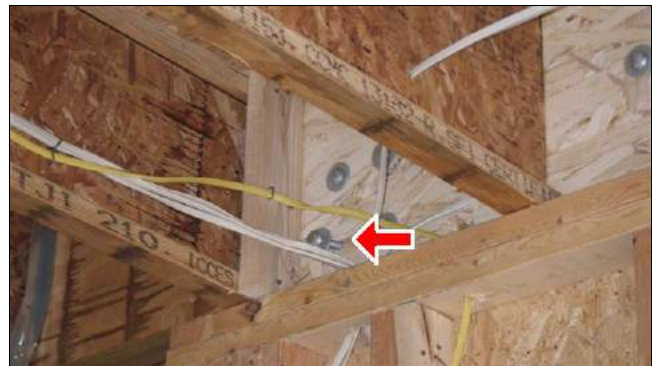
21. Two of the deck bolts are loose.

Two of the deck bolts are loose.

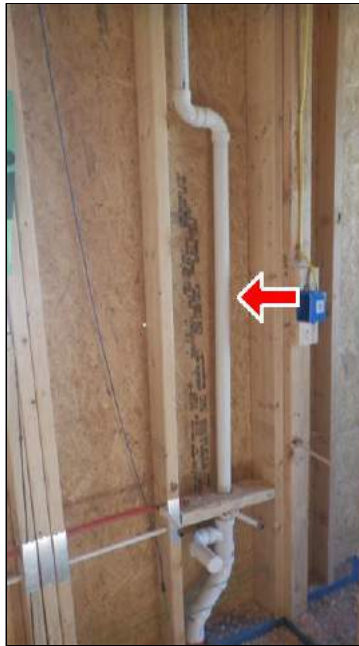
22. Inside the 1st floor full bath, the vertical vent stack pipe is not secured.

Inside the 1st floor full bath, the vertical vent stack pipe is not secured.

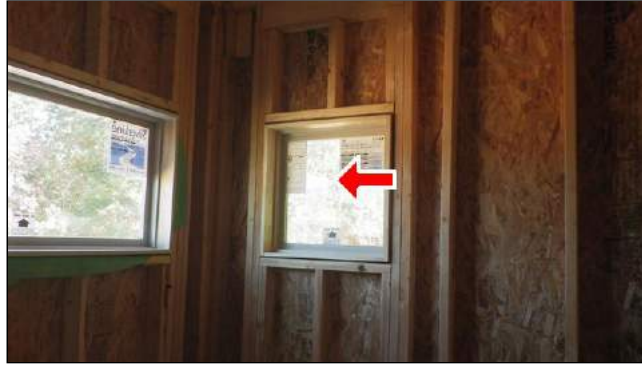
23. The smaller window above the master tub is lacking required tempered glass.

The smaller window above the master tub is lacking required tempered glass.
