Inspection Report

Property Address:
1856 Alpine Way
Duluth GA

Dana Home Inspections, Inc.

Date: 8/22/2016**Property:**1856 Alpine Way
Duluth GA**Customer:**

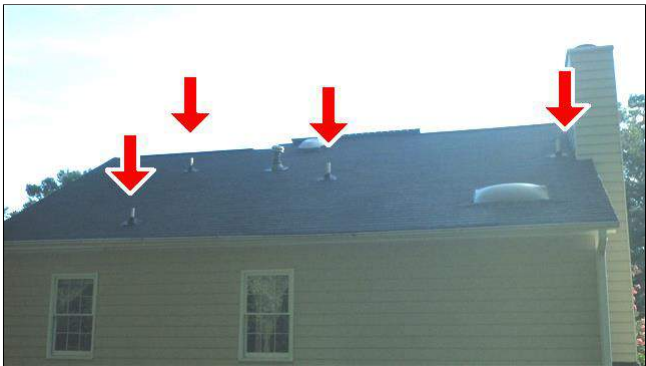
1. The roof is in need of immediate replacement with the following issues observed:
 1. Several active leaks detected inside the attic, including some decking damage.
 2. Deteriorated plumbing vent boots.
 3. Unusual rafter separation that is allowing a lot of daylight (and possible moisture) into the attic.
 4. One cracked rafter.
 5. Cracked overhanging ridge shingles.
 6. Leaking around the skylight, as detected using an infrared camera and moisture meter.

Bad boots

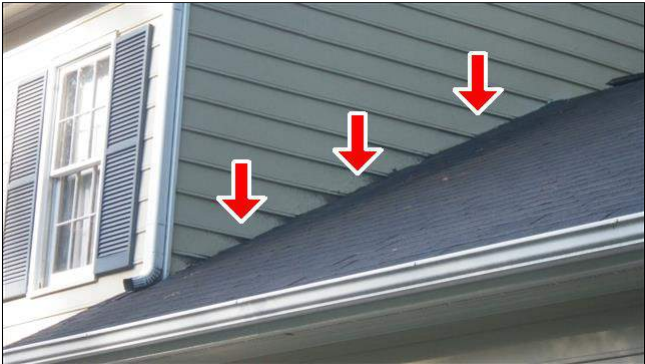
2. Sidewall flashing at the small roofed areas of the chimney chase do not appear to be installed well and should be further evaluated and repaired by a qualified roofer.

Front sidewall

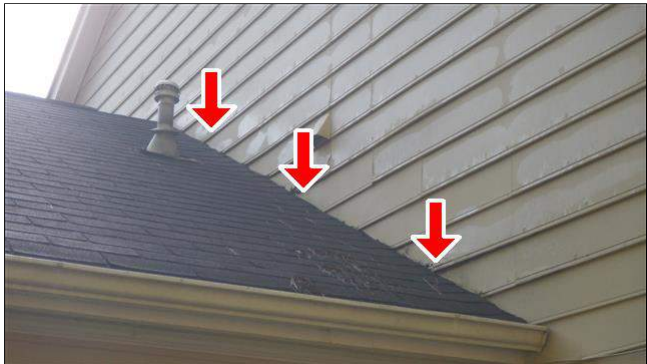
Back sidewall

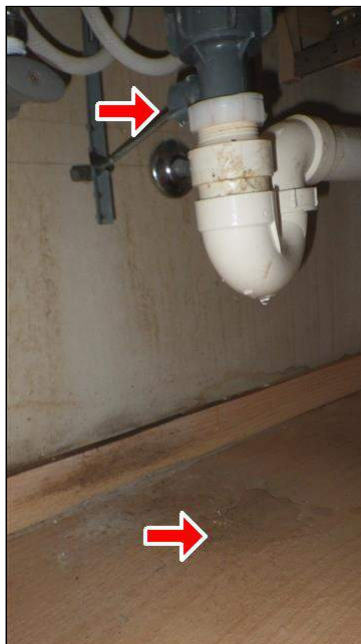
28. (4) The kitchen sink faucet is not adequately secured to prevent movement.
29. (5) The 2nd floor guest bathroom sink is leaking inside the cabinet from the sink stopper connection.

(5) The 2nd floor guest bathroom sink is leaking inside the cabinet from the sink stopper connection.

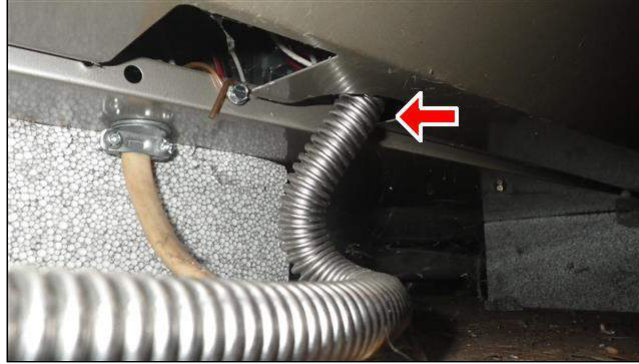
(1) A rigid gas pipe is needed going into the furnace cabinet as the flex pipe can get damaged from the sharp edges of the cabinet opening.

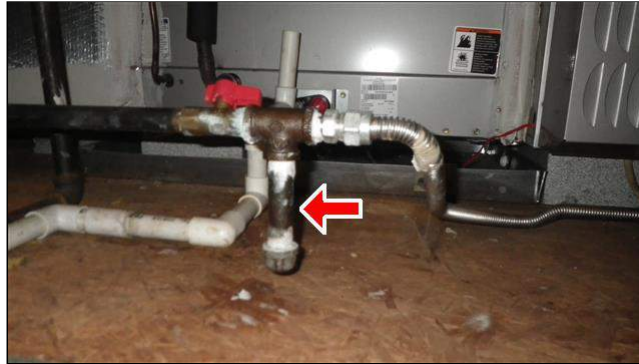
(2) The existing sediment trap in the attic for the furnace is no longer considered adequate. However, this will not have any negative impact and can be changed at some point in the future.
