Inspection Report

Property Address:
4742 Union Hill Road
Canton GA 30115

Dana Home Inspections, Inc.

Date: 11/3/2016**Property:**4742 Union Hill Road
Canton GA 30115**Customer:**

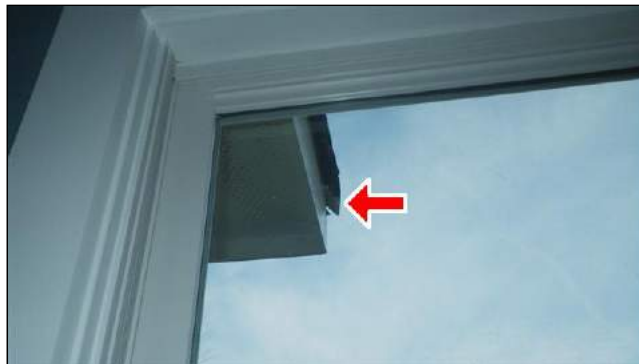
1. (1) A cracked shingle was observed looking out from the master tub window.
2. (2) Exposed nailheads were observed on shingles above the master bathroom window.

(1) A cracked shingle was observed looking out from the master tub window.

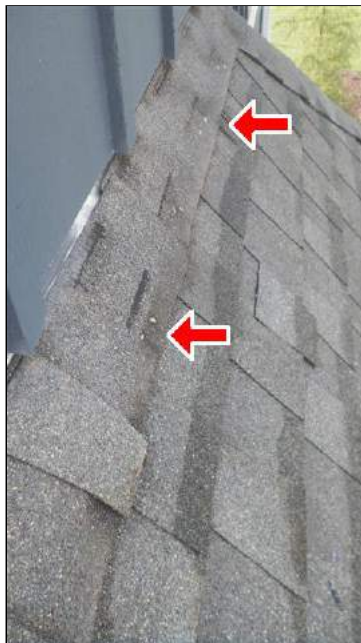
(2) Exposed nailheads were observed on shingles above the master bathroom window.

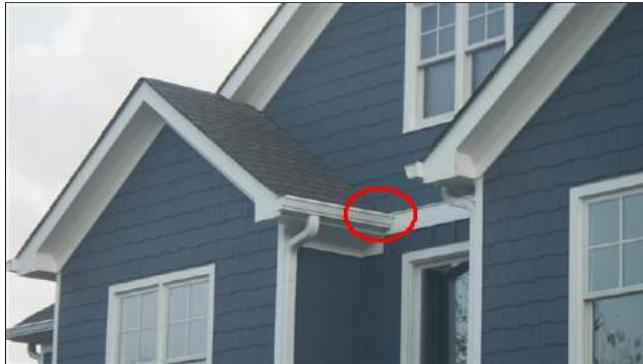
Front sidewall, example

(2) At all sidewalls around the house, the flashing was not installed to divert water into the gutter or away from the house. Have reviewed and corrected where needed.

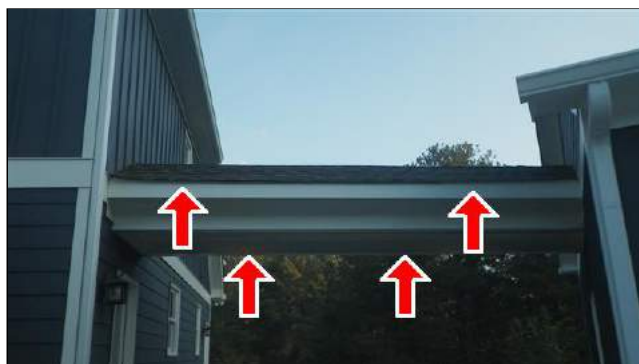
6. Gutters are missing at the breezeway roof between the garage and house.

Gutters are missing at the breezeway roof between the garage and house.

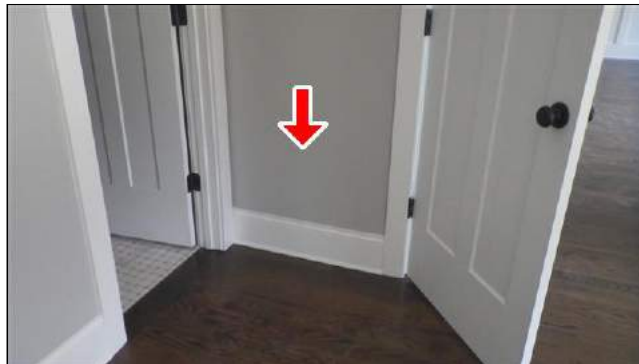
- 22. An outlet is missing at a wall over 2' wide inside the 1st floor office room.

An outlet is missing at a wall over 2' wide inside the 1st floor office room.

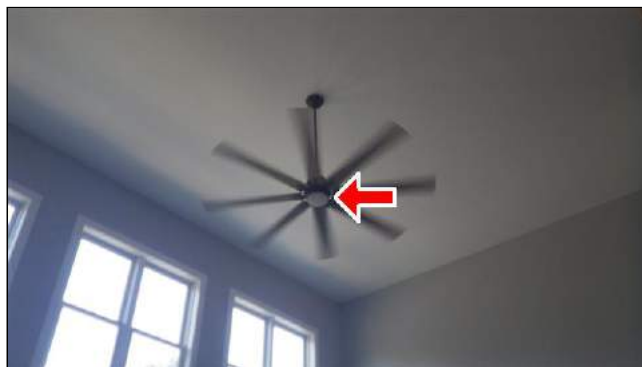
(4) I was unable to get the family room ceiling fan light to come on.

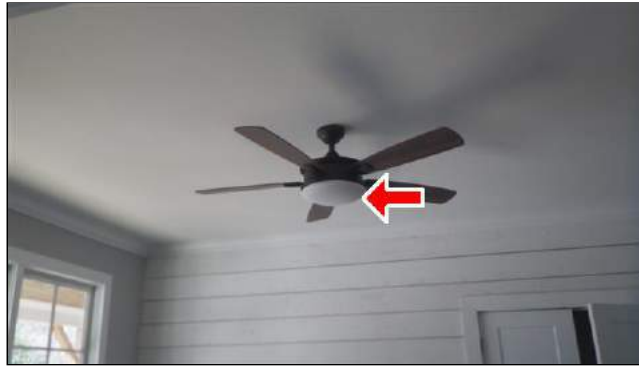
(5) I was unable to confirm operation of the 1st floor office light and fan.

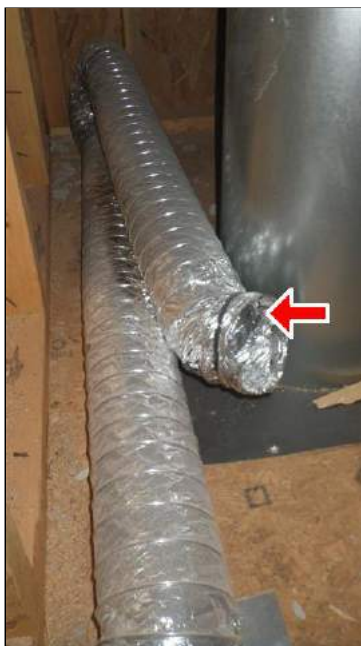
- 42. The fireplace air intake duct has come loose inside the chimney case.

The fireplace air intake duct has come loose inside the chimney case.

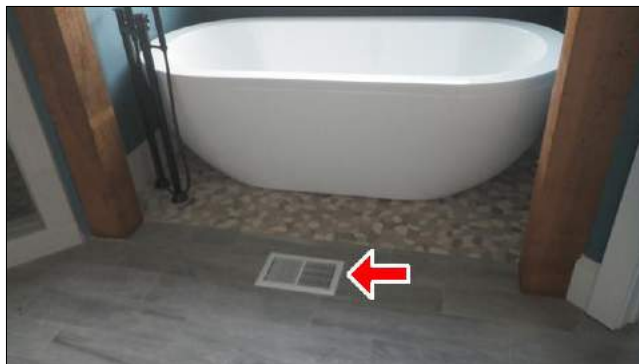
(1) The master bathroom floor vent was installed in an unusual location, directly in front of the bathtub where a bath mat would typically go.

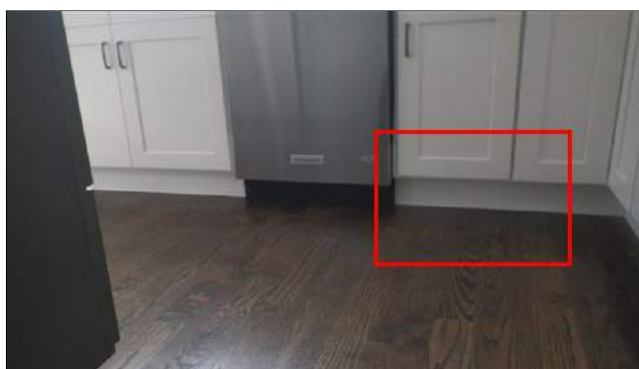
(2) A hole was not cut out for the supply vent into the kitchen.

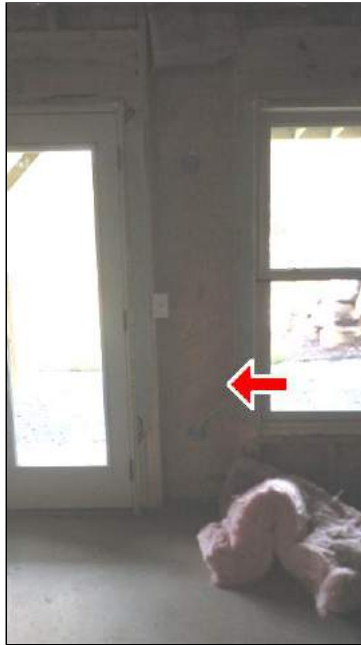
47. A batt of insulation is loose next to the back basement door.

A batt of insulation is loose next to the back basement door.

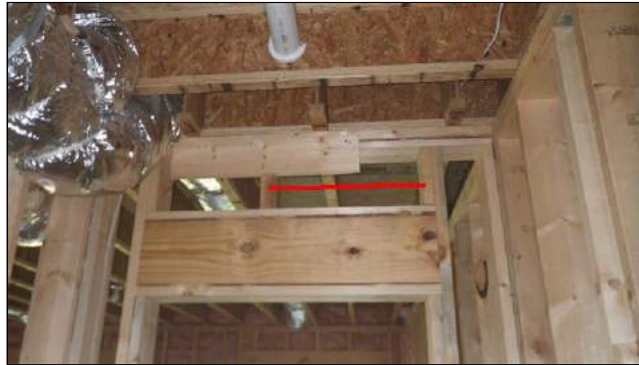
(1) Inside the basement above the doorway leading to the room below the master bedroom, a set of studs in a support wall are spaced over 16" on-center.

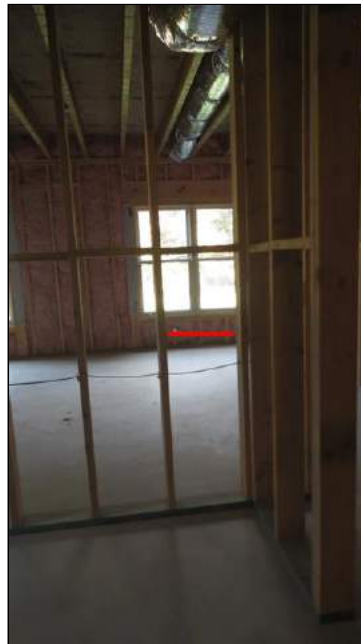
(2) Inside the basement next to the doorway leading to the room below the master bedroom, a set of studs in a support wall are spaced over 16" on-center.

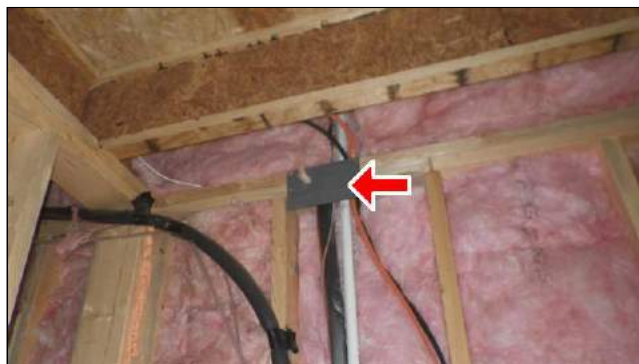
(2) The wrong type of metal plate is in use where the A/C line sets penetrate the wooden top plate in the basement. The resulting hole in the wooden top plate is over 50% of the width of the plate, requiring a structural metal plate. The existing metal plate is merely for protection.

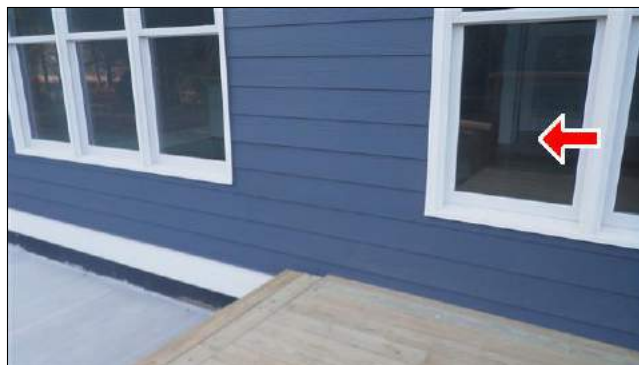
The window closest to the top of the deck staircase is lacking required tempered safety glass as it is within 36" of the top of the staircase, and is also less than 36" above the walking surface.

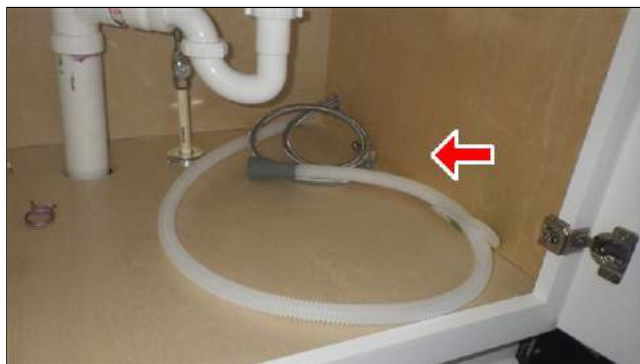
The dishwasher installation has not been completed.

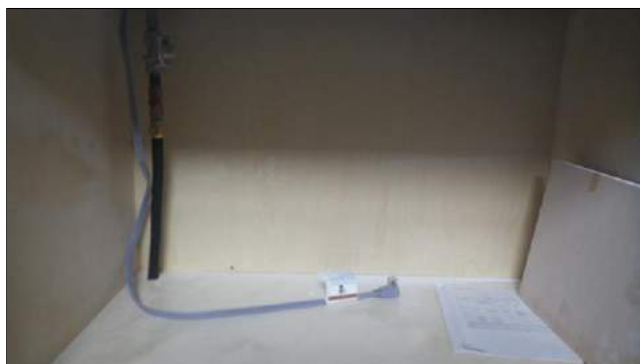
The stovetop installation has not been completed.
